INSPECTION REPORT

For the Property at:
1234 INSPECTION STREET
PUYALLUP, WA 98374

Prepared for: BUYER .
Inspection Date: Wednesday, October 9, 2024
Prepared by: Chad Fletcher

RE: Report No. 1616, v.0
1234 inspection street
Puyallup, WA
98374

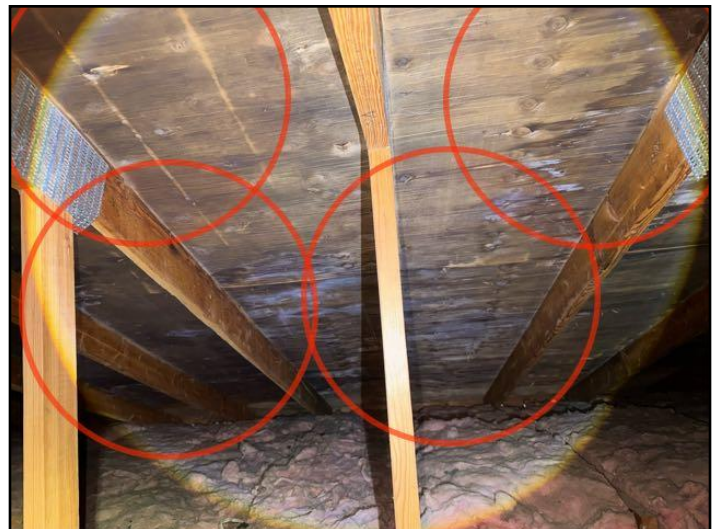
8. Water stains

Condition: • [Water stains](#)

Water stains and organic growth found throughout attic. There are signs that the water stains are leaks and leaking into the insulation. Thermal imaging found dozens of spots where the sheathing was cold and had water stains. I tested the For moisture and had high levels. I tested another spot without water stains for moisture as a control and it was more than half as much moisture. All of these signs and the condition of the shingles indicate the roof is leaking and past its life expectancy.

Fungus growth is a common thing to find in the Pacific Northwest due to its climate. Presence of mold should be tested for which type and whether it is hazardous or not. A mold remediation company should be contacted for further evaluation and to do proper remediation. These companies have special skills and practices that that ensure the proper procedures are done. There are multiple types of remediation including removing the mold from the area and fogging. Methods applied to correct a mold issue depends on where, severity of quantity, and the type of mold. Common causes of mold in attics are roof leaks, improper attic ventilation, or a disconnected vent from a moist area IE bathrooms and kitchens. Occasionally when newer homes are built the wood materials are wet from outside storage and the growth occurs during the construction process. The cause for the mold should be addressed when attempting remediation or the problem may persist. Applying a mold resistant primer will not kill the mold and merely will hide it. If attempting to correct a mold issue yourself please read the labels on the product and look for mold killer not mold resistant. Dead mold may still affect someone will allergies. If attempting to remove and clean mold yourself, dish soap is a good way to scrub it off, bleach can help kill anything left, and mold prevention primer can help prevent it. Masks should be worn and proper PPE should be worn. Any section being cleaned should be blocked off and clothes worn should be removed before entering into living space to help prevent mold spores from attaching into living spaces. See EPA website below for more information. <https://www.epa.gov/mold> It is normal for some fungal spores to be present in a normal indoor environment; however, no EPA regulations exist for safe air quality related to mold. Several agencies (EPA, CDC, OSHA) have guidelines for interpreting mold results, but have no threshold for quantity.

Task: Replace roof and remediate attic droppings and organic growth

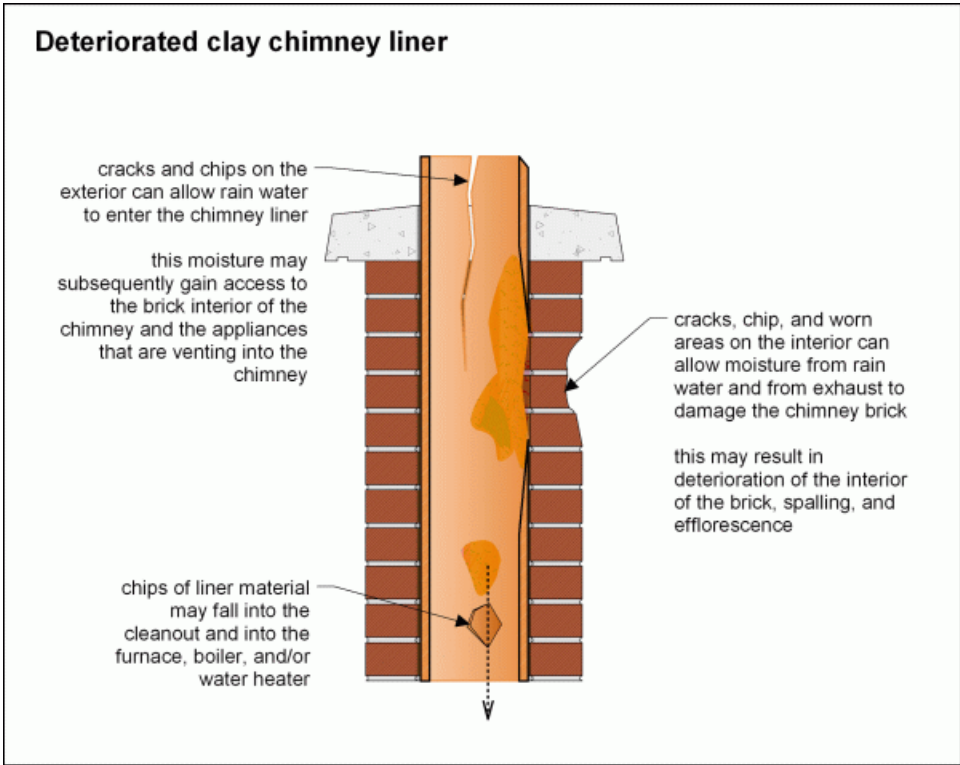
15. Loose, missing or deteriorated masonry

Condition: • [Loose, missing or deteriorated masonry](#)

Some bricks are breaking apart and parts of the chimney crown are deteriorating and leaving holes that could leak.

Task: Further evaluation by qualified professional recommended to repair or replace and correct issue as needed.

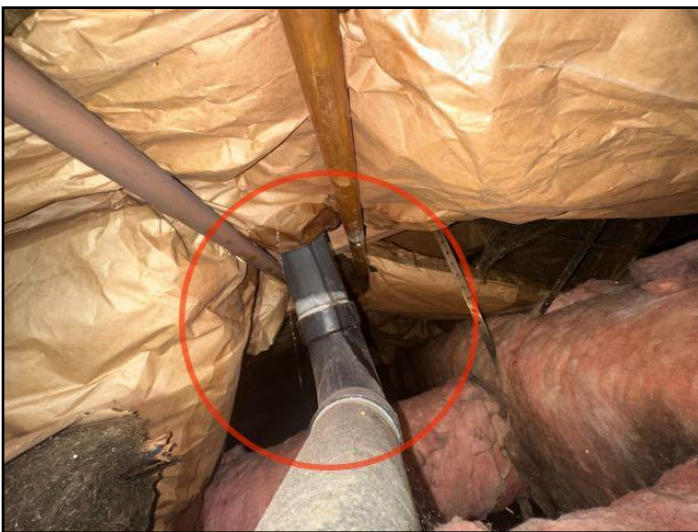
22.

Condition: • There are several leaks in the crawlspace, some near the bathrooms, some under, and some closer to the hall. There is signs of water staining on the floor joists which may indicate this has been going on a while. The sub flooring is saturated with moisture and is shown on the laminate flooring in the bathroom. Most of the moisture appears to be under the sink cabinet.

Task: Further evaluation by qualified professional recommended to repair or replace and correct issue as needed.

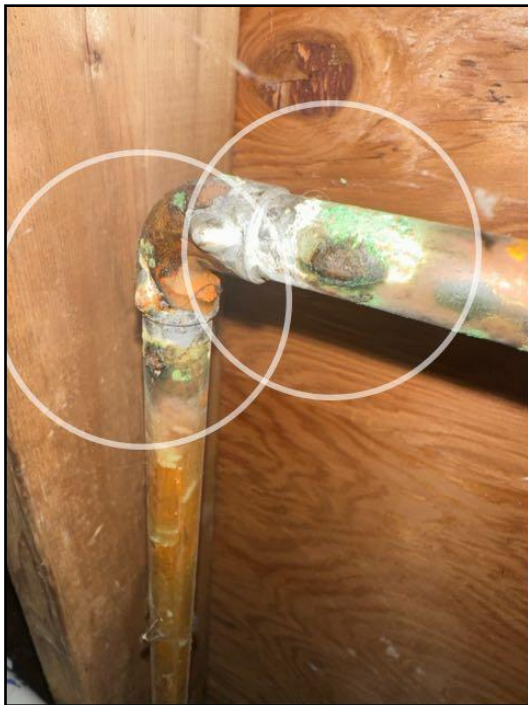
30. Corrosion

Condition: • Corrosion

Copper pipes, along with most pipes have a life expectancy which may be around 50 years depending on quality of product and installation methods. There are some signs that help gauge the condition. Discoloration would be greenish or bluish stains on the pipes, which can indicate corrosion. Visible leaks or wet spots around the pipes. Low water pressure could be due to mineral buildup or corrosion inside the pipes. If the water tastes or smells metallic, it could be a sign of corrosion in the pipes. Dents bulges or other physical damage to the pipes, which could indicate issues. A licensed professional should further evaluate if any of these conditions arise. Solder flux will cause copper pipes to turn green if not wiped off. The discoloration is limited to areas bordering soldered joints, so it is likely caused by the flux not being wiped off back when the connections were originally soldered. It should be limited to surface discoloration, so I'd use something abrasive like emery cloth or steel wool to remove it. See link below for education on copper pipes life expectancy. <https://todayshomeowner.com/plumbing/guides/how-long-does-copper-pipe-last/>

Task: Have plumber evaluate and replace if needed

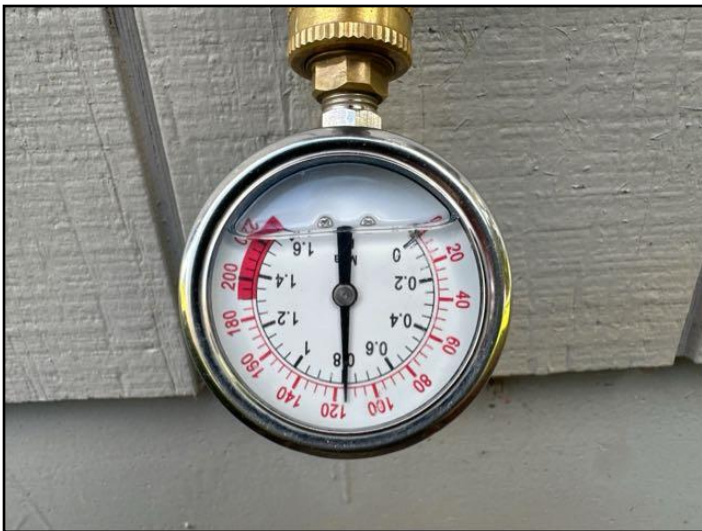
32. Recommended due to high supply water...

Condition: • Recommended due to high supply water pressure

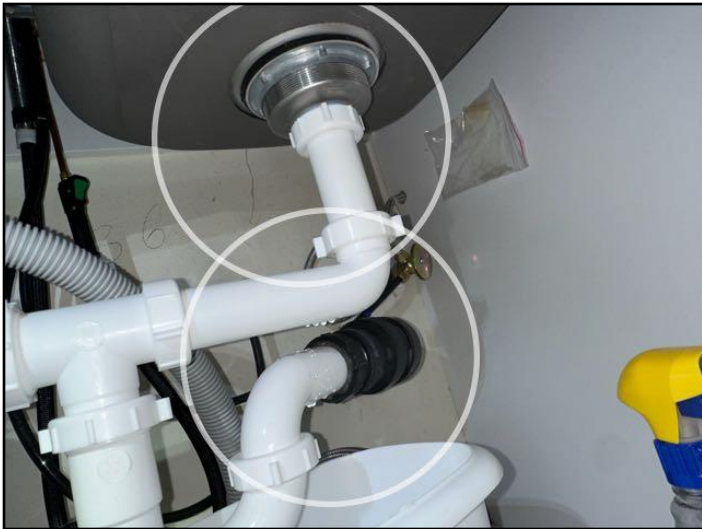
35. Leak

Condition: • [Leak](#)

Task: Further evaluation by qualified professional recommended to repair or replace and correct issue as needed.

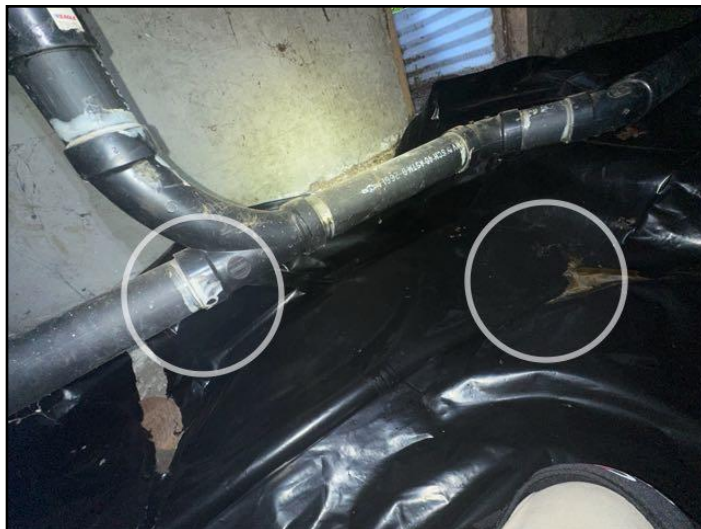
37. Leak

Condition: • [Leak](#)

Task: Further evaluation by qualified professional recommended to repair or replace and correct issue as needed.

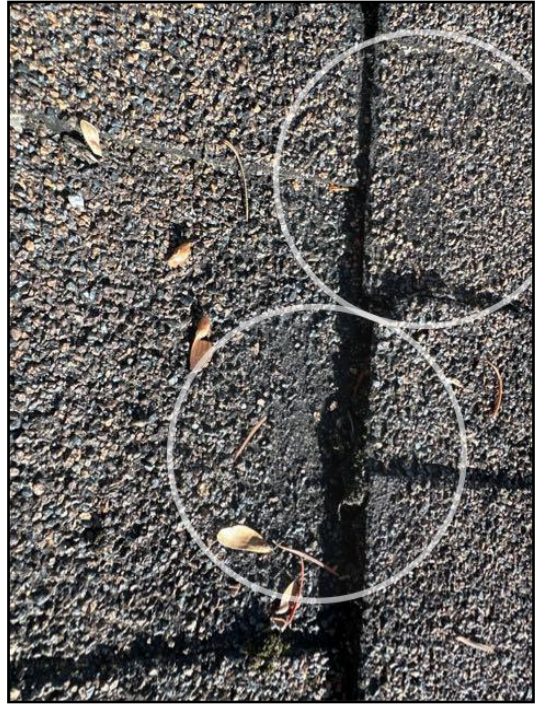
50. Granule loss

Condition: • [Granule loss](#)

Severe granule loss on the southern side and mostly near the chimney. Some shingles have less than 10% of granules left. While walking on the roof more granules were slipping off. Most of the southern side has medium to heavy granule loss. Granule loss happens as roofs get older and they start separating from the shingles. It is a way to help gauge how much older a roof is getting and one of the most common things roofs experience during the aging process. When granules on the roof start to feel slippery, have high amounts missing, or are developing high amounts of granules in the gutters, then the roof is likely past its life expectancy and leaking. A roofer would be needed to help try and predict how much life is left before leaks and moisture can develop in the attic. Architectural shingles typically have an average life span of 25 years, 3-tab shingles approximately 20 years, and residential shingles around 30 years. The life expectancies vary by many factors. Some of them are quality of product, quality of installation, weather and season patterns, and upkeep. Extreme heat events that last longer than usual can cause the shingles to dry up the asphalt, crack, and lose some of its life expectancy. Moss on roofs is very common and without treating and removing it can reduce the life expectancy. Moss usually grows on Northern portions of roofs and more often near trees. Moss can grow or regrow on roofs sometimes in just a year and typically is not a factor in gauging the condition or age of the roof. The Southern parts of the roof usually catch the brunt of weather and can deteriorate quicker than other parts.

Task: Replace roof and remediate attic droppings and organic growth

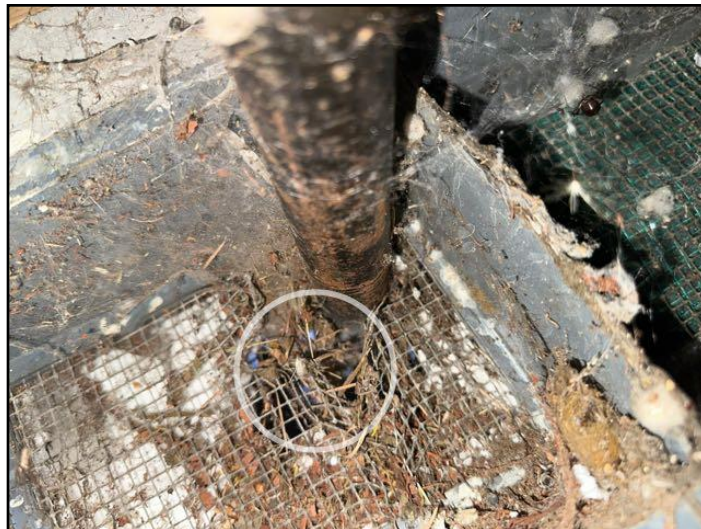
52.

Condition: • Gaps around a crawlspace vent where pests could get in.

Task: Seal

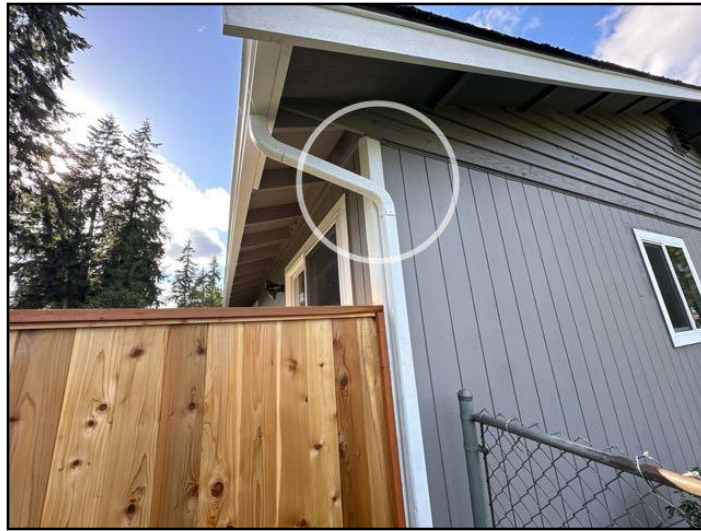
53. Connections loose

Condition: • [Connections loose](#)

Missing fastener

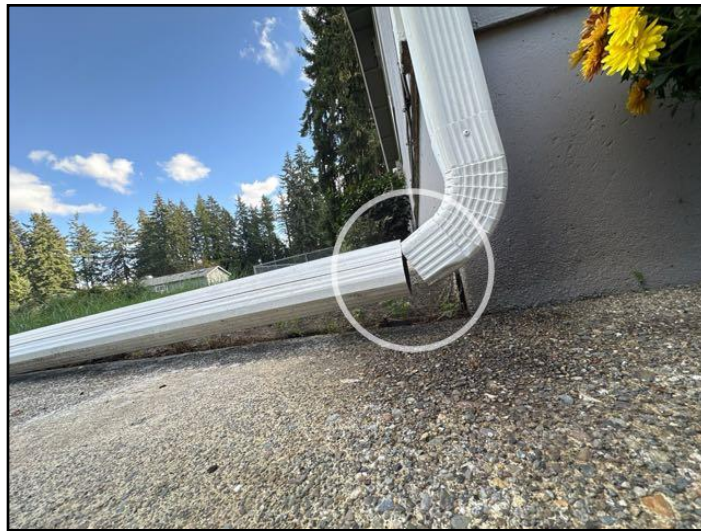
54. Connections loose

Condition: • [Connections loose](#)

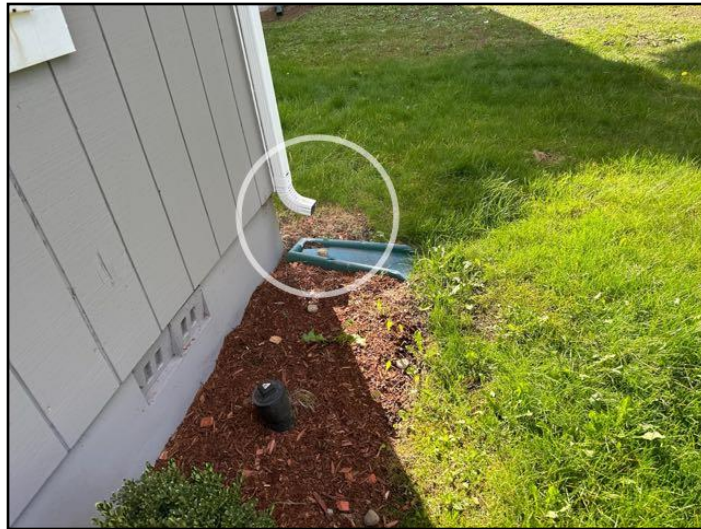
55. Discharge too close to building

Condition: • [Discharge too close to building](#)

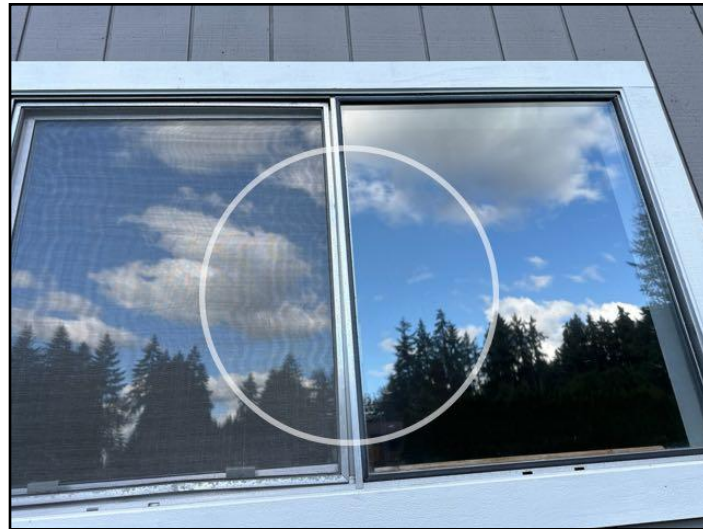
59. Lost seal on double or triple glazing

Condition: • [Lost seal on double or triple glazing](#)

Moisture between panes.

Task: Repair or replace

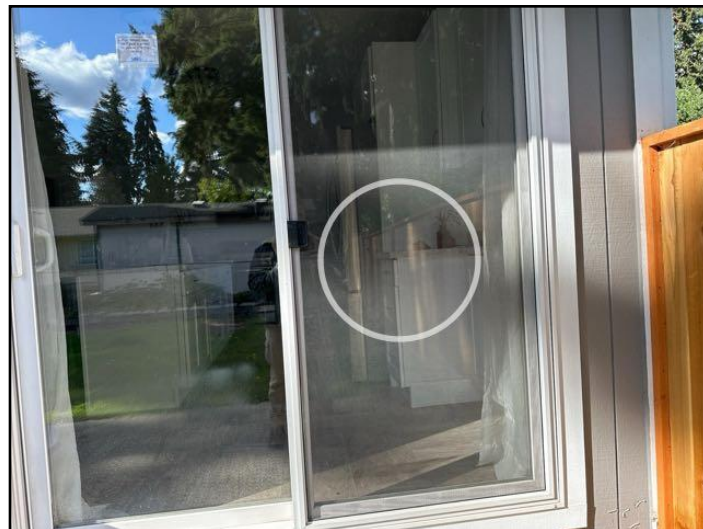
60.

Condition: • The back door sliding screen is a little difficult to open.

Task: Adjust/correct

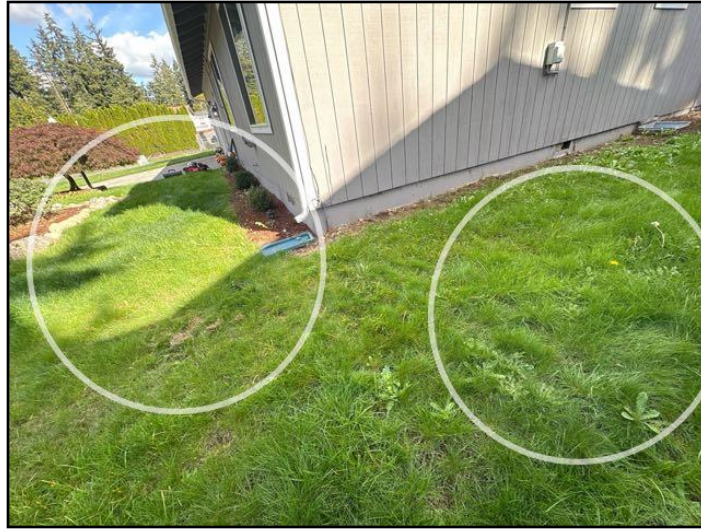
65. *Improper slope or drainage*

Condition: • [Improper slope or drainage](#)

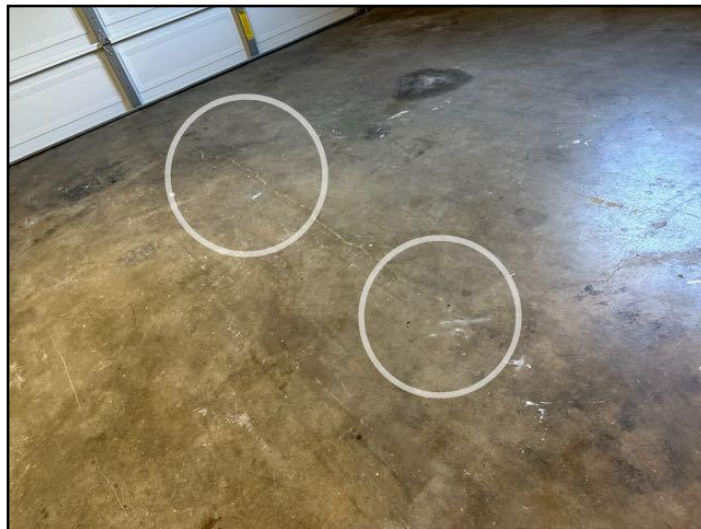
68. Cracked

Condition: • [Cracked](#)

Task: Periodically monitor and seal if needed

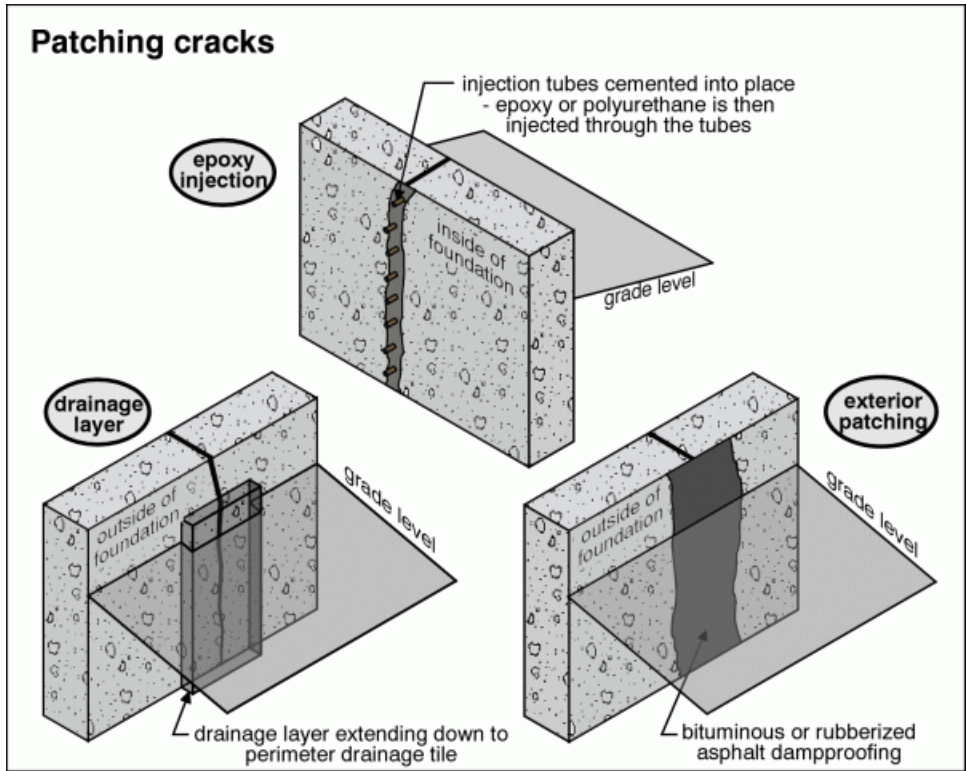
83. Typical minor cracks

Condition: • Typical minor cracks

Typical minor foundation cracks. Foundation cracking is extremely common even in brand new homes. Poured concrete shrinks during the curing process, which usually results in small cracks. Cracking usually doesn't need to be addressed unless they are more significant, have specific angles, and there is evidence of continuous movement. If the cracks are wide enough, water can sometimes seep through and get into a crawlspace or basement. In these situations they should be sealed from the outside. Cracks wider than 1/4 inch should always be evaluated by a structural contractor.

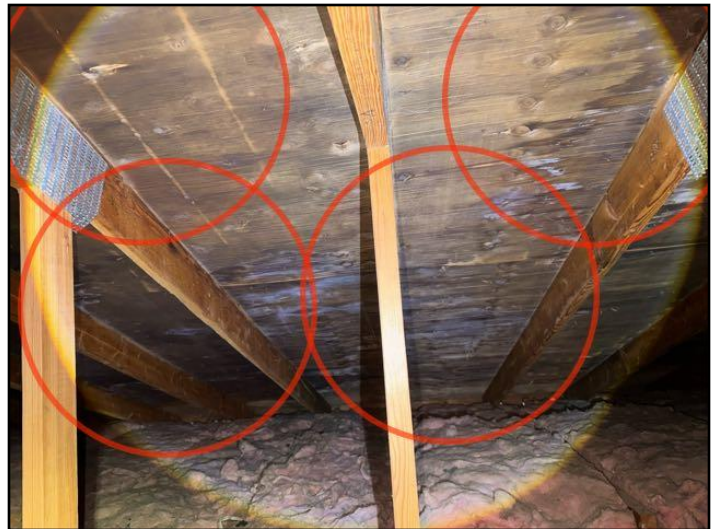
86. Water stains

Condition: • [Water stains](#)

Water stains and organic growth found throughout attic. There are signs that the water stains are leaks and leaking into the insulation. Thermal imaging found dozens of spots where the sheathing was cold and had water stains. I tested the For moisture and had high levels. I tested another spot without water stains for moisture as a control and it was more than half as much moisture. All of these signs and the condition of the shingles indicate the roof is leaking and past its life expectancy.

Fungus growth is a common thing to find in the Pacific Northwest due to its climate. Presence of mold should be tested for which type and whether it is hazardous or not. A mold remediation company should be contacted for further evaluation and to do proper remediation. These companies have special skills and practices that ensure the proper procedures are done. There are multiple types of remediation including removing the mold from the area and fogging. Methods applied to correct a mold issue depends on where, severity of quantity, and the type of mold. Common causes of mold in attics are roof leaks, improper attic ventilation, or a disconnected vent from a moist area IE bathrooms and kitchens. Occasionally when newer homes are built the wood materials are wet from outside storage and the growth occurs during the construction process. The cause for the mold should be addressed when attempting remediation or the problem may persist. Applying a mold resistant primer will not kill the mold and merely will hide it. If attempting to correct a mold issue yourself please read the labels on the product and look for mold killer not mold resistant. Dead mold may still affect someone with allergies. If attempting to remove and clean mold yourself, dish soap is a good way to scrub it off, bleach can help kill anything left, and mold prevention primer can help prevent it. Masks should be worn and proper PPE should be worn. Any section being cleaned should be blocked off and clothes worn should be removed before entering into living space to help prevent mold spores from attaching into living spaces. See EPA website below for more information. <https://www.epa.gov/mold> It is normal for some fungal spores to be present in a normal indoor environment; however, no EPA regulations exist for safe air quality related to mold. Several agencies (EPA, CDC, OSHA) have guidelines for interpreting mold results, but have no threshold for quantity.

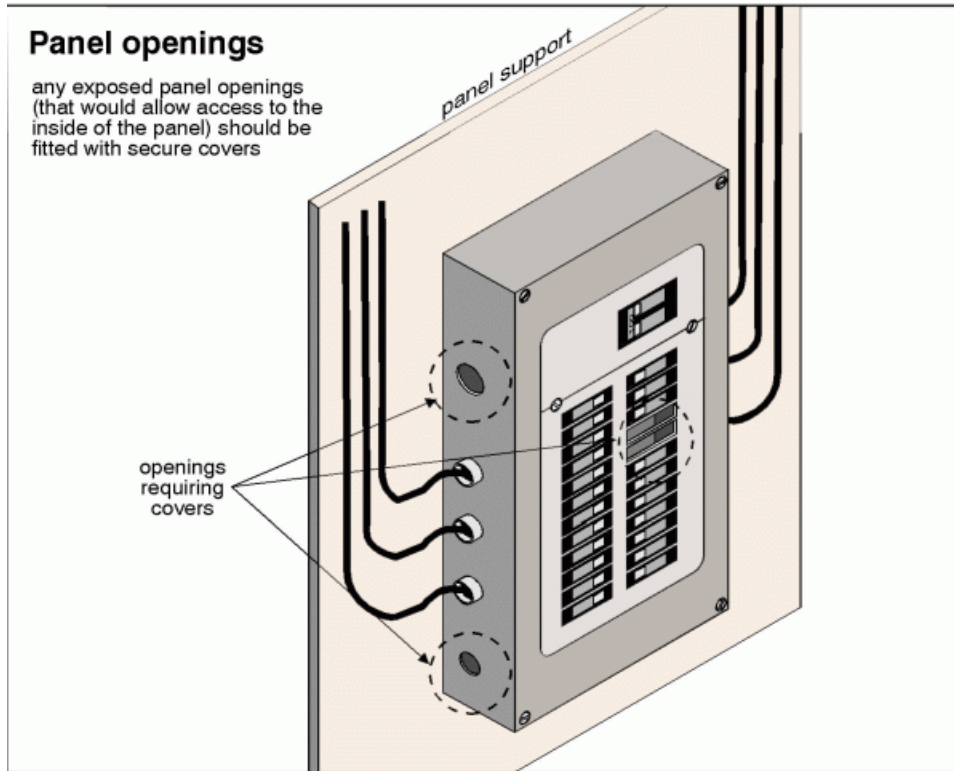
Condition: • [Openings in panel](#)

Openings in the sub panel dead front cover.

Task: Provide fittings to cover for safety

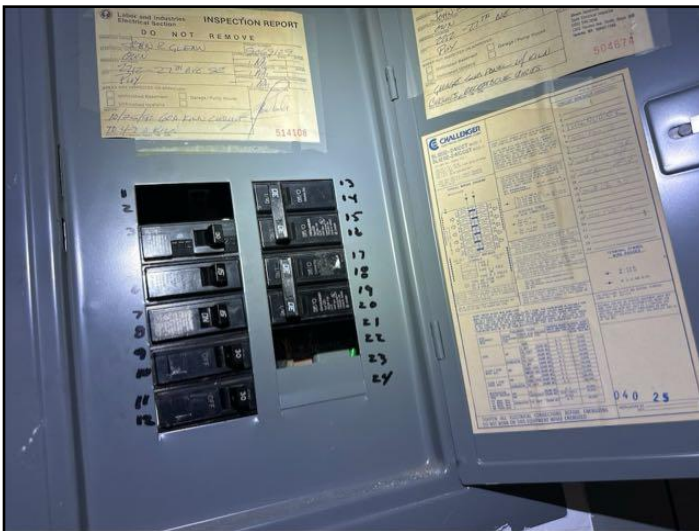
97.

Condition: • Picture of sub panel. No overheating found

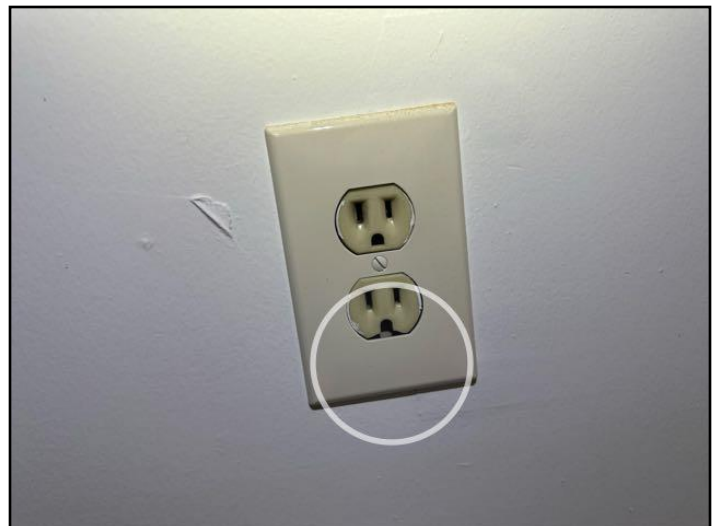
101. Damage

Condition: • [Damage](#)

Damaged receptacles should be replaced and are typically older. Older receptacles and some cheaper quality types will often experience issues especially in activity areas including but not limited to bedrooms, kitchens, and often exterior receptacles are common to have damage. Over time they become loose, grounding slots can get damaged, and plugs won't sit snug inside. All these issues can become safety issues, can loosen wires and possibly cause other issues including arcing. Furniture and storage can sometimes limit the inspection. When any of these conditions are apparent I recommend having a licensed electrician evaluate all receptacles for any issues and repair or replace as needed.

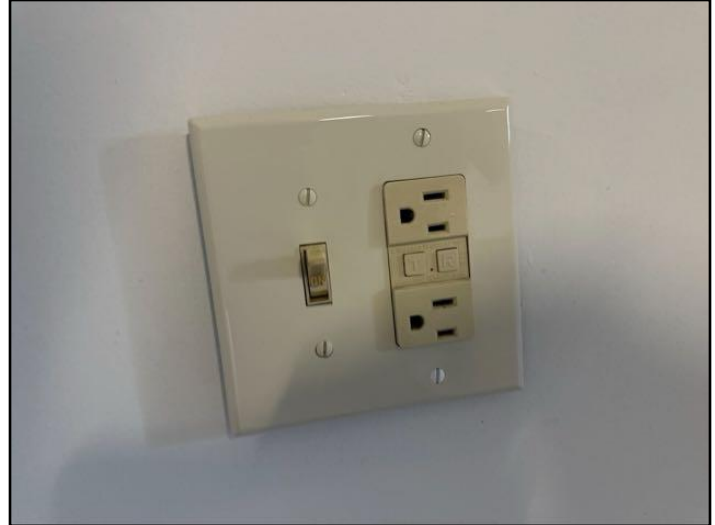
103. Inoperative

Condition: • [Inoperative](#)

Task: Further evaluation by qualified professional recommended to repair or replace and correct issue as needed.

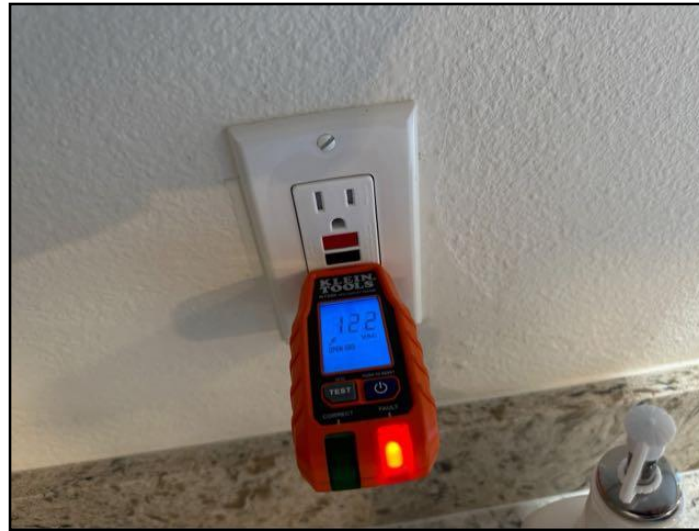
104. Ungrounded

Condition: • [Ungrounded](#)

Ungrounded outlets are a safety hazard. Mid century homes and before commonly would have ungrounded wiring and or knob and tube wiring. Upgrading the wiring to grounded NMC would be the best option but can be expensive. Upgrading the outlets or breakers with GFCI dual AFCI combination types with a label(no equipment ground) is a less expensive option. This would protect against ground faults and arcing. Some older electrical panels won't allow for AFCI breakers. Regardless of whether you replace the wiring with grounding or not, these safety devices are still recommended to be installed. Older ungrounded outlets should always be evaluated by a licensed electrician to help identify damaged wires, loose wires, or any other safety issues that may not be readily available during a non invasive visual home inspection. Newer homes that have ungrounded outlets could be caused by other issues and should be corrected. Ungrounded outlets should be corrected as soon as possible.

Task: Further evaluation and see if it's an installation issue.

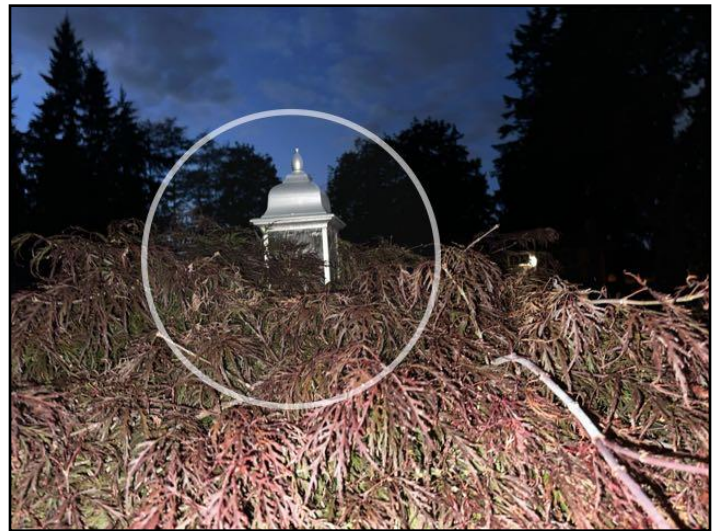
110. Inoperative

Condition: • [Inoperative](#)

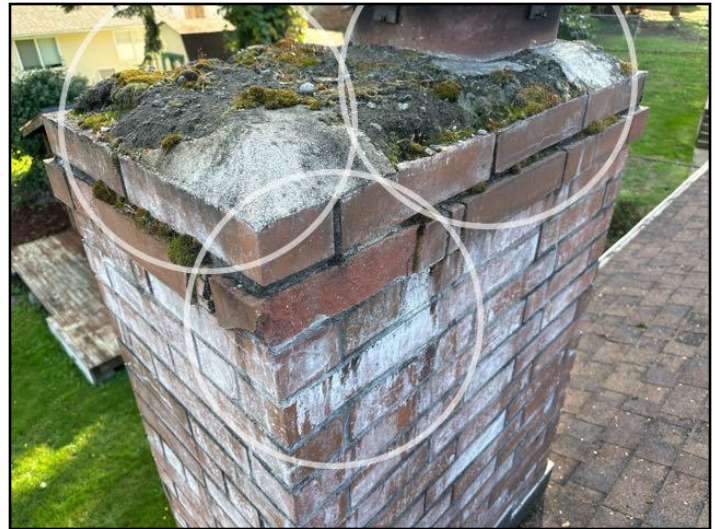
122. Loose, missing or deteriorated masonry

Some bricks are breaking apart and parts of the chimney crown are deteriorating and leaving holes that could leak.

Task: Further evaluation by qualified professional recommended to repair or replace and correct issue as needed.

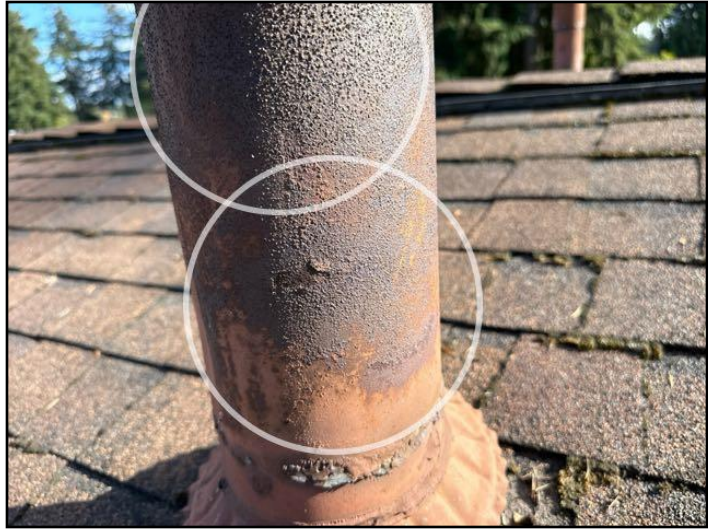
125. Rust

Condition: • Rust

The metal vent is heavily rusted and starting to flake apart

Task: Replace

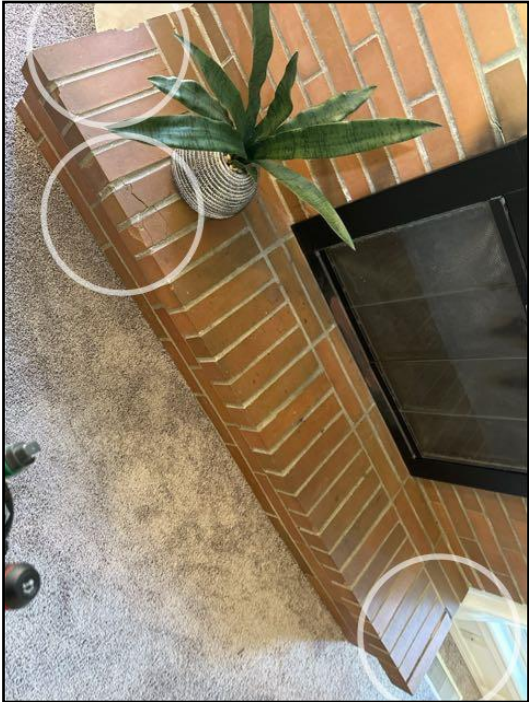
126.

Condition: • Loose and cracked brick

Task: Repair

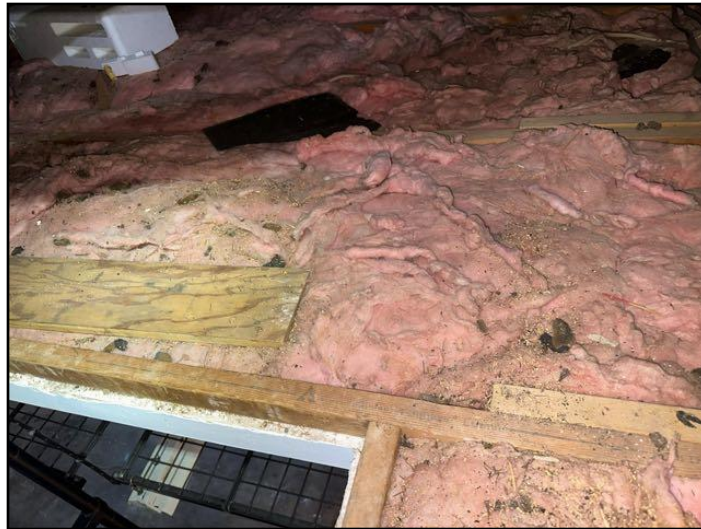
130. Animal/pest droppings in attic

Condition: • Animal/pest droppings in attic

Several dozens of animal droppings in attic. Pest droppings found in crawlspace and or attic. Pest droppings is a highly common thing to find. It does not mean there is a pest issue or isn't one. It is easy for pests to get into into any crawlspace without gaps on homes because they can get in from just digging under the foundation. Typically if they are getting into the crawlspace in older uninsulated walled homes, they can be getting into the attic as well. Steps are recommended to be taken to help prevent this issue which a pest professional should further evaluate the crawlspace. Crawlspace vents and areas around a crawlspace should be checked to help prevent pests. Measures may or may not have already been taken to correct this issue but a home inspection only notes on information visually provided during the time and day of inspection. Looking for signs including amount of droppings, insulation torn, and disturbed vapor barriers are helpful ways to identify the level of severity. Correcting any damages, as well as cleaning any droppings and replacing damaged insulation is recommended. Home inspectors are not pest professionals and always recommend further evaluation. Having a pest service once a year is a great way to help prevent issues. Please see EPA guidelines link for more information.

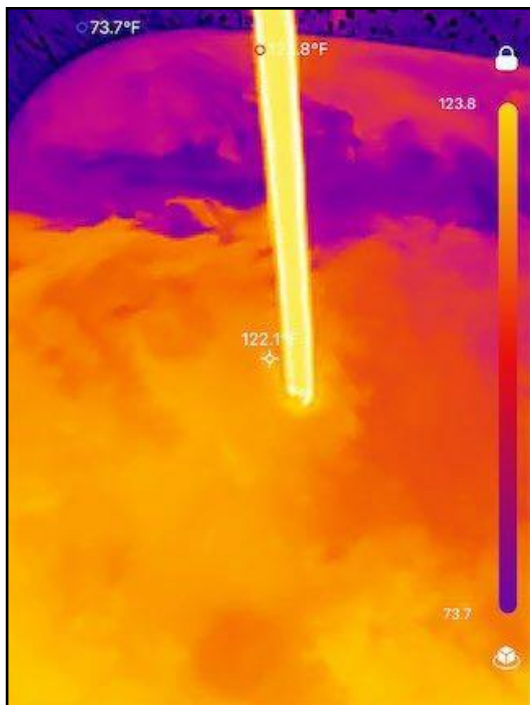
141.

Condition: • Water is too hot. The recommended water temperature is approximately 120 degrees. Anything over that can cause 3rd degree burns if in contact for too long. Small children are more susceptible to this. If the temperature is below 120 degrees the water could potentially grow bacteria quicker. The temperature taken with the thermal camera is not exact and may be off by a couple degrees.

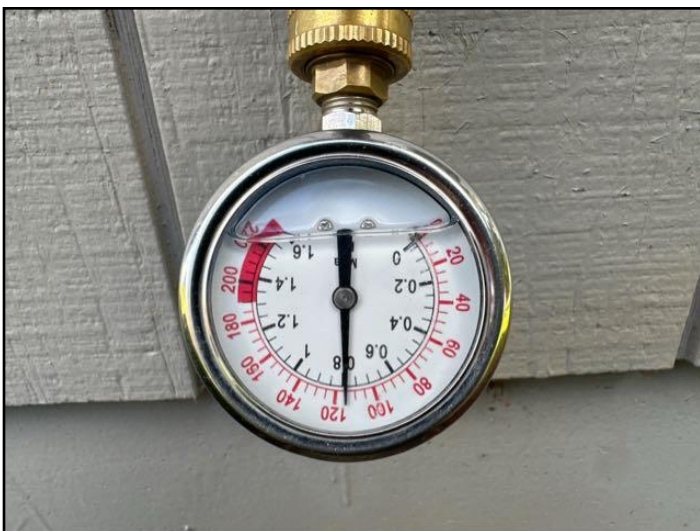
155. Recommended due to high supply water...

Condition: • Recommended due to high supply water pressure
Residential plumbing should be between 40-80PSI.

Task: There appears to be a pressure regulator in the crawlspace where the new water service line comes in.

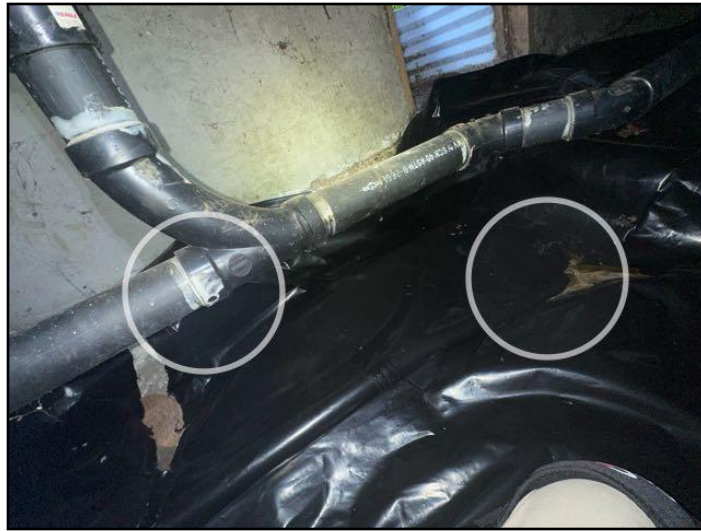
160. Leak

Condition: • [Leak](#)

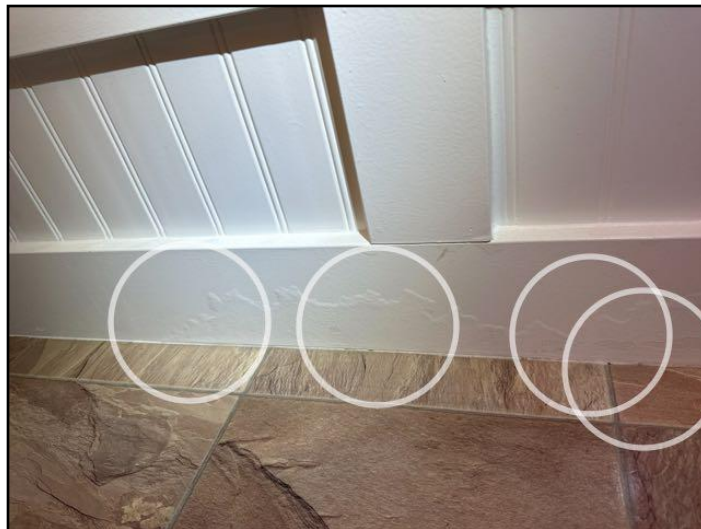
163.

Condition: • Signs of swelling at tub trim. It may get worse as time goes on

Task: Monitor, Repair or replace if needed

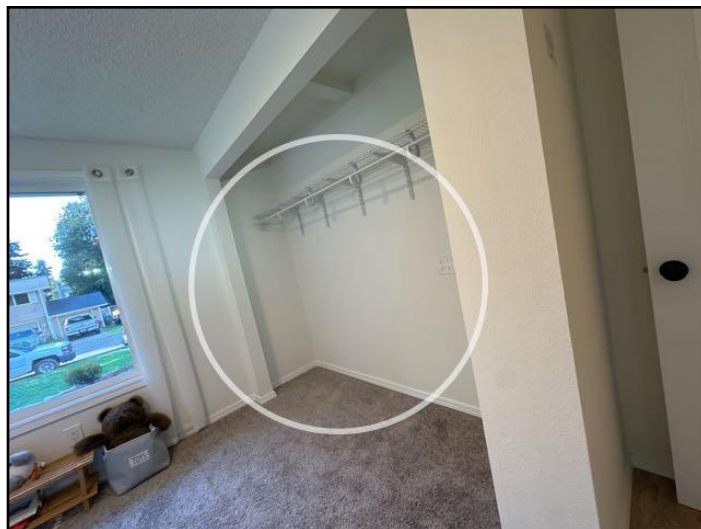
165.

Condition: • No closet doors

Location: NW bedroom

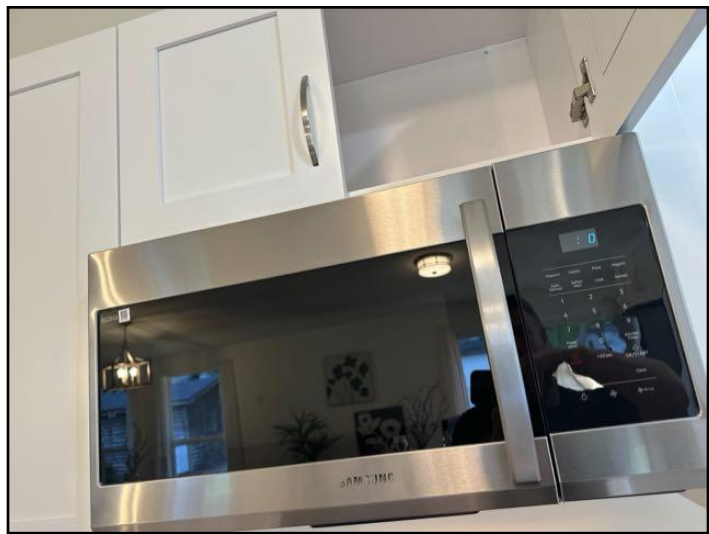
168. Not vented to exterior

Condition: • Not vented to exterior

The microwave is installed as a re-circulating filtered vent. Venting to the exterior is recommended for moisture control

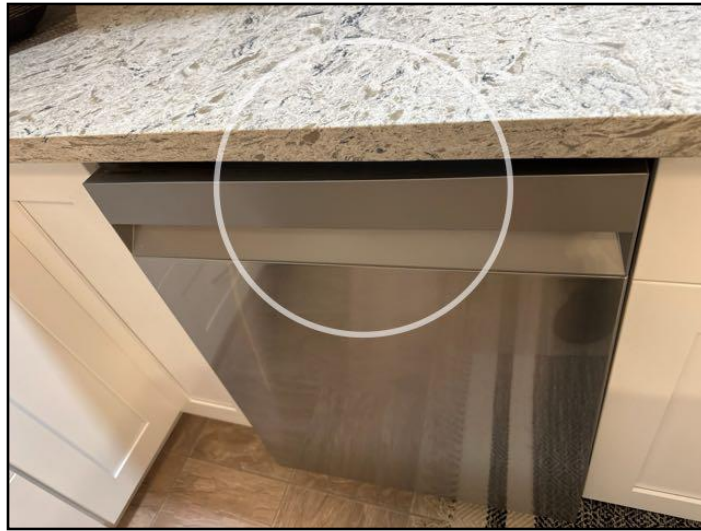
173.

Condition: • The dishwasher is crooked

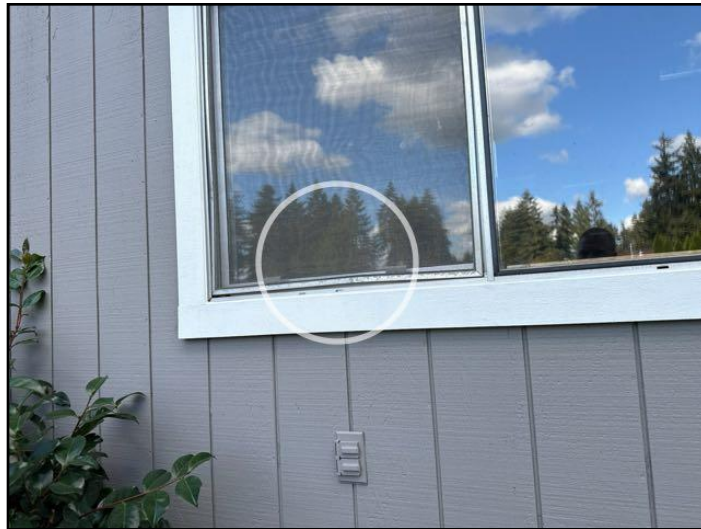
176.

Condition: • Bent window screen
