INSPECTION REPORT

L123 INSPECTION ST

Prepared for: BRAND NEW HOME
Inspection Date: Thursday, December 5, 2024
Prepared by: Chad Fletcher

RE: Report No. 1665, v.0 I123 inspection st Frederickson, WA 98446

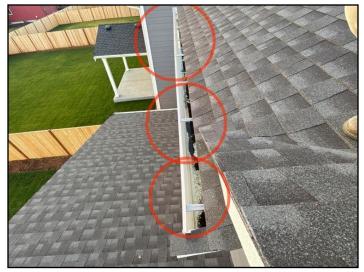
1. Improper slope, ponding

Condition: • Improper slope, ponding Gutter still ponds on South side of house

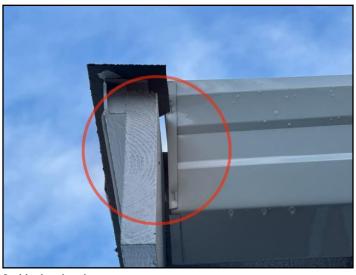
3. Undersized

Condition: • Undersized

Gutters need to extend all the way to the gable boards without gaps for several important reasons: Prevent Water Damage to Fascia and Siding: If there is a gap, water can bypass the gutter system, soaking the fascia boards, siding, and the edge of the roof. This can lead to rot, mold, and structural issues over time.

Direct Water Away from the Foundation: Gaps in the gutter can allow water to drip directly to the ground near the foundation, potentially causing soil erosion, foundation settling, or basement leaks.

Protect Landscaping: Water escaping through gaps may erode soil or damage plants and landscaping below. Avoid Staining and Ice Issues: Gaps in gutters can lead to water streaks or staining on the siding. In colder climates, dripping water can freeze, creating icicles or ice dams that pose safety hazards and additional damage risks. Ensure Efficient Drainage: Gutters are designed as a continuous system to capture and direct water efficiently. Gaps disrupt this system, reducing its effectiveness.

By ensuring the gutters extend all the way to the gable boards, you create a seamless barrier that protects the home's structure and surrounding environment.

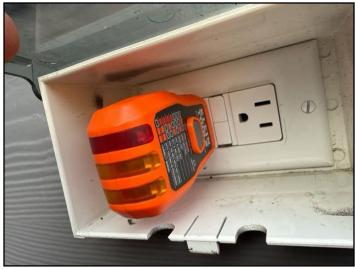
Condition: • If the back exterior GFCI gets tripped, it must first be reset at a garage receptacle before you can reset it at the exterior.

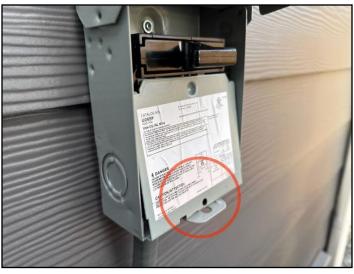
5.

Condition: • Missing bolt at the heat pump disconnect cover which is an electrical safety issue.

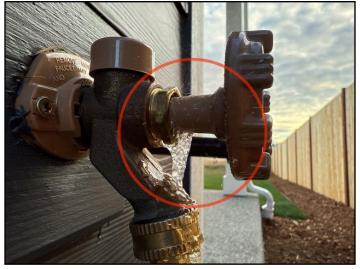
6. Leak or drip

Condition: • Leak or drip

While the hose bib valve is open(turned on) and under pressure(impeding the flow of water) it leaks. This could potentially allow water to damage siding or finished behind it. This would also be a nuisance when using a sprayer attachment for a hose as well as excess water loss. Unfortunately this is a common defect to find even with newer hose bibs but should be corrected or replaced.

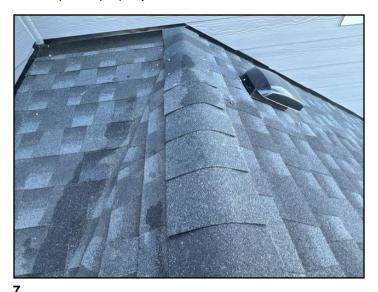
General: • Damaged roof area was repaired properly

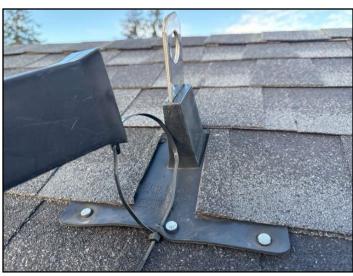
General: • The support with zip tie was properly seeded with roof. Zip tie is okay to stay.

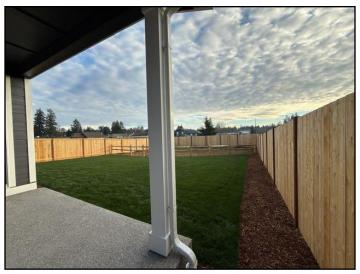
9.

General: • Proper fastener was installed for downspout.

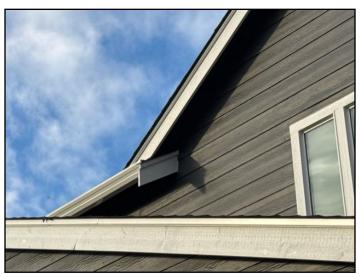
General: • Painting paper was removed.

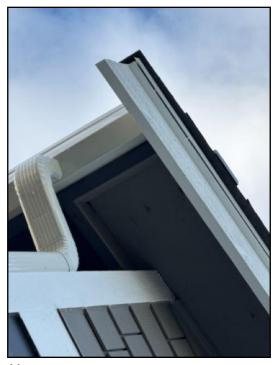
General: • NE eves were painted.

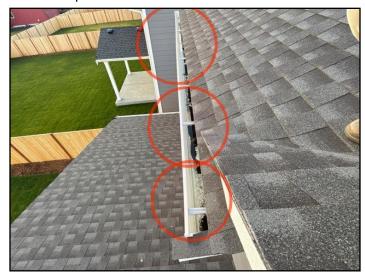
12. Improper slope, ponding

Condition: • Improper slope, ponding Gutter still ponds on South side of house

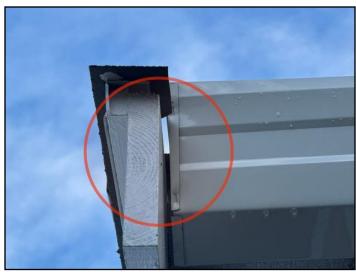
14. Undersized

Condition: • Undersized

Gutters need to extend all the way to the gable boards without gaps for several important reasons: Prevent Water Damage to Fascia and Siding: If there is a gap, water can bypass the gutter system, soaking the fascia boards, siding, and the edge of the roof. This can lead to rot, mold, and structural issues over time.

Direct Water Away from the Foundation: Gaps in the gutter can allow water to drip directly to the ground near the foundation, potentially causing soil erosion, foundation settling, or basement leaks.

Protect Landscaping: Water escaping through gaps may erode soil or damage plants and landscaping below. Avoid Staining and Ice Issues: Gaps in gutters can lead to water streaks or staining on the siding. In colder climates, dripping water can freeze, creating icicles or ice dams that pose safety hazards and additional damage risks. Ensure Efficient Drainage: Gutters are designed as a continuous system to capture and direct water efficiently. Gaps disrupt this system, reducing its effectiveness.

By ensuring the gutters extend all the way to the gable boards, you create a seamless barrier that protects the home's structure and surrounding environment.

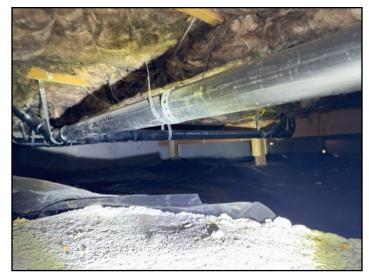
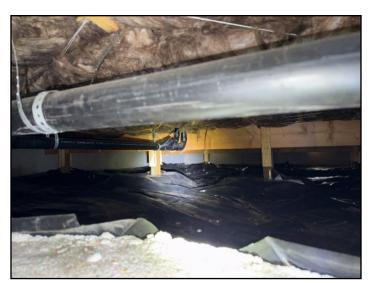
15. 16.

General: • Hanging insulation was fixed.

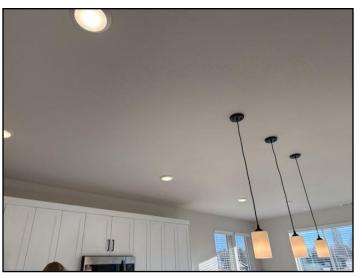
18.

General: • Light was fixed in kitchen.

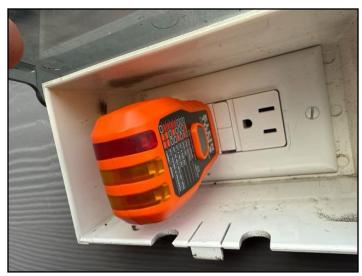
19.

Condition: • If the back exterior GFCI gets tripped, it must first be reset at a garage receptacle before you can reset it at the exterior.

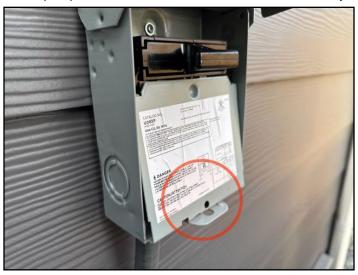
20.

Condition: • Missing bolt at the heat pump disconnect cover which is an electrical safety issue.

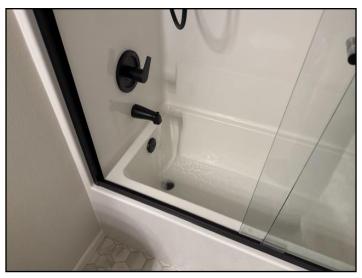
21.

General: • Tub faucet had adequate flow.

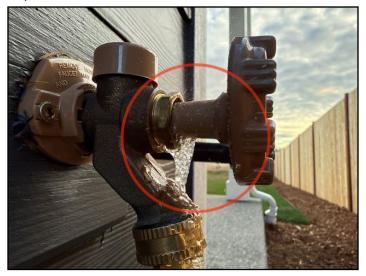
22. Leak or drip

Condition: • Leak or drip

While the hose bib valve is open(turned on) and under pressure(impeding the flow of water) it leaks. This could potentially allow water to damage siding or finished behind it. This would also be a nuisance when using a sprayer attachment for a hose as well as excess water loss. Unfortunately this is a common defect to find even with newer hose bibs but should be corrected or replaced.

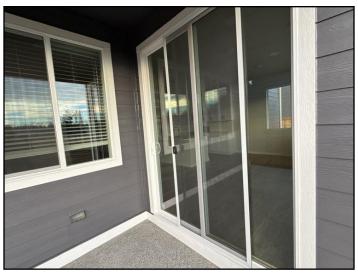
23.

General: • Screen door was fixed

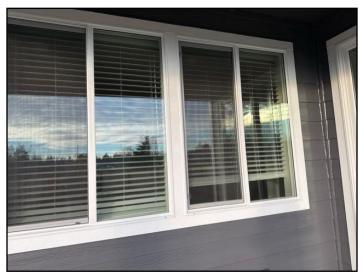
24.

General: • Window screen was added.

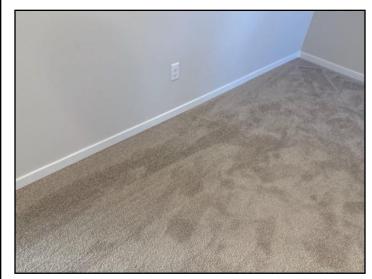
25.

General: • Paint was removed upstairs in both areas of flooring

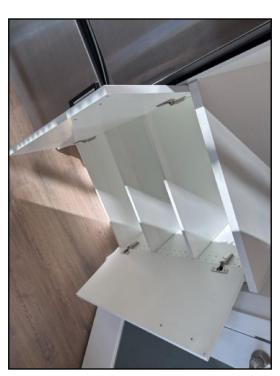
General: • Cabinet door was fixed.
