INSPECTION REPORT

For the Property at:
1234 INSPECTION STREET
PUYALLUP, WA 98374

Prepared for: BUYER .
Inspection Date: Wednesday, October 9, 2024
Prepared by: Chad Fletcher

RE: Report No. 1616, v.0
1234 inspection street
Puyallup, WA
98374

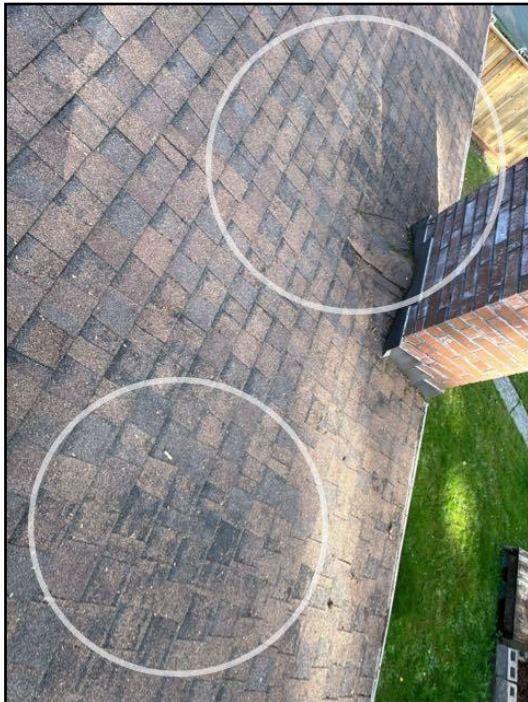
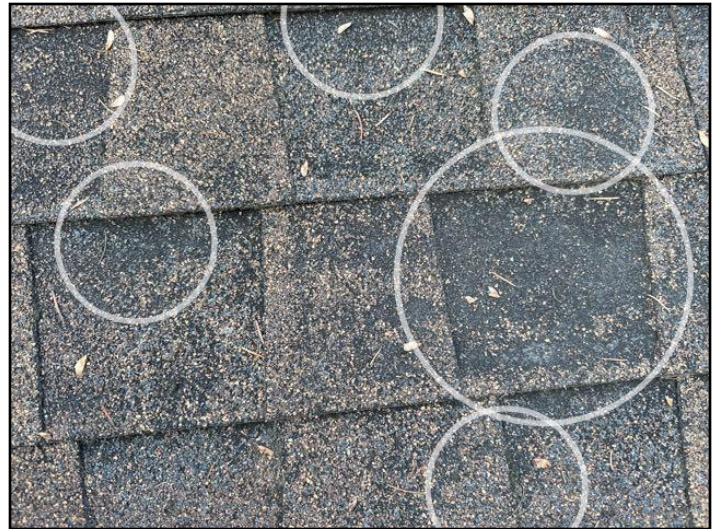
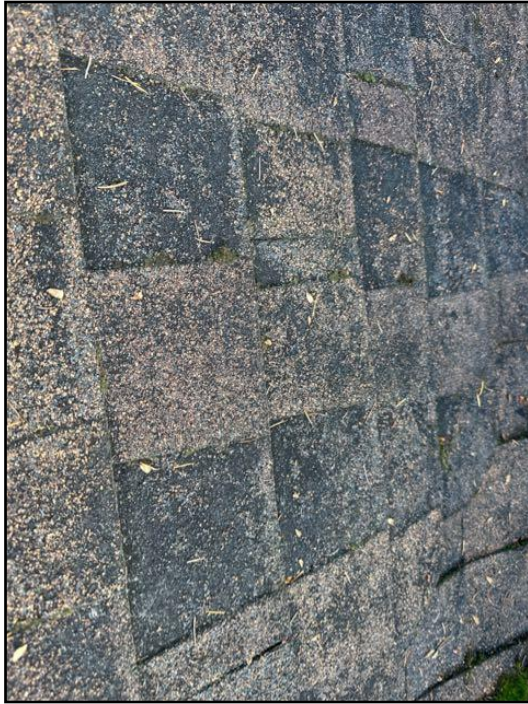
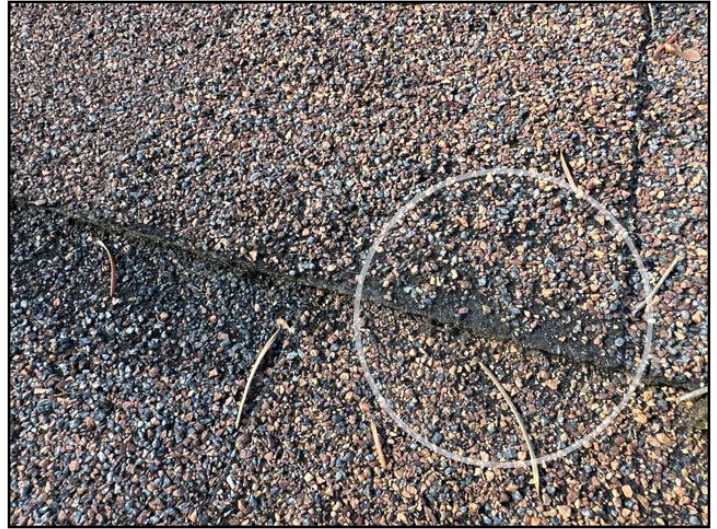
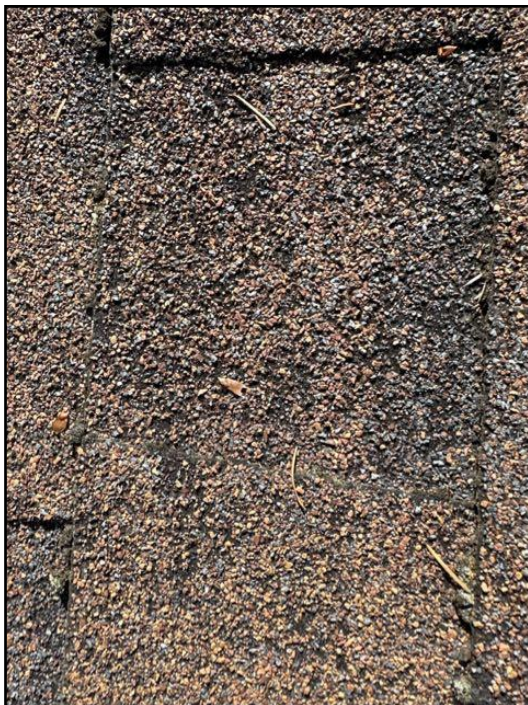
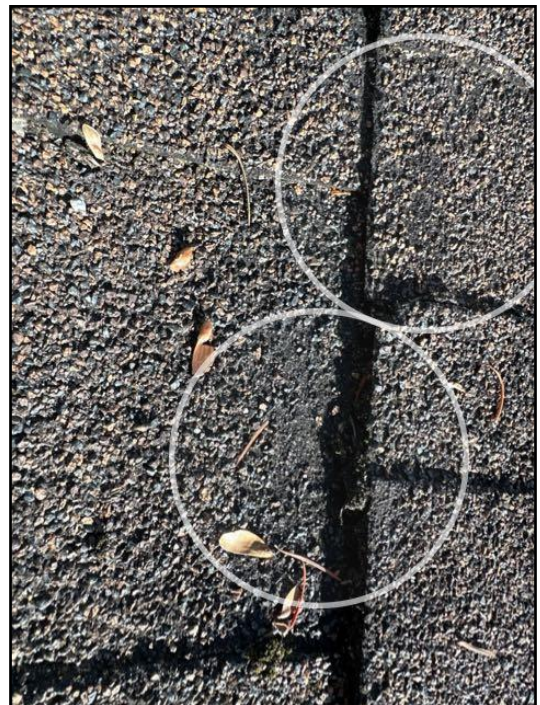
Condition: • [Granule loss](#)

Severe granule loss on the southern side and mostly near the chimney. Some shingles have less than 10% of granules left. While walking on the roof more granules were slipping off. Most of the southern side has medium to heavy granule loss. Granule loss happens as roofs get older and they start separating from the shingles. It is a way to help gauge how much older a roof is getting and one of the most common things roofs experience during the aging process. When granules on the roof start to feel slippery, have high amounts missing, or are developing high amounts of granules in the gutters, then the roof is likely past its life expectancy and leaking. A roofer would be needed to help try and predict how much life is left before leaks and moisture can develop in the attic. Architectural shingles typically have an average life span of 25 years, 3-tab shingles approximately 20 years, and presidential shingles around 30 years. The life expectancies vary by many factors. Some of them are quality of product, quality of installation, weather and season patterns, and upkeep. Extreme heat events that last longer than usual can cause the shingles to dry up the asphalt, crack, and lose some of its life expectancy. Moss on roofs is very common and without treating and removing it can reduce the life expectancy. Moss usually grows on Northern portions of roofs and more often near trees. Moss can grow or regrow on roofs sometimes in just a year and typically is not a factor in gauging the condition or age of the roof. The Southern parts of the roof usually catch the brunt of weather and can deteriorate quicker than other parts.

Task: Replace roof and remediate attic droppings and organic growth

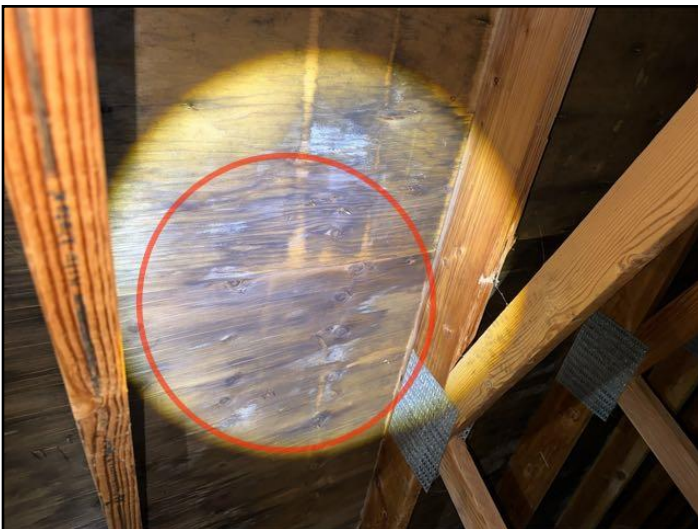
7. Water stains

Condition: • [Water stains](#)

Water stains and organic growth found throughout attic. There are signs that the water stains are leaks and leaking into the insulation. Thermal imaging found dozens of spots where the sheathing was cold and had water stains. I tested the For moisture and had high levels. I tested another spot without water stains for moisture as a control and it was more than half as much moisture. All of these signs and the condition of the shingles indicate the roof is leaking and past its life expectancy.

Fungus growth is a common thing to find in the Pacific Northwest due to its climate. Presence of mold should be tested for which type and whether it is hazardous or not. A mold remediation company should be contacted for further evaluation and to do proper remediation. These companies have special skills and practices that that ensure the proper procedures are done. There are multiple types of remediation including removing the mold from the area and fogging. Methods applied to correct a mold issue depends on where, severity of quantity, and the type of mold. Common causes of mold in attics are roof leaks, improper attic ventilation, or a disconnected vent from a moist area IE bathrooms and kitchens. Occasionally when newer homes are built the wood materials are wet from outside storage and the growth occurs during the construction process. The cause for the mold should be addressed when attempting remediation or the problem may persist. Applying a mold resistant primer will not kill the mold and merely will hide it. If attempting to correct a mold issue yourself please read the labels on the product and look for mold killer not mold resistant. Dead mold may still affect someone will allergies. If attempting to remove and clean mold yourself, dish soap is a good way to scrub it off, bleach can help kill anything left, and mold prevention primer can help prevent it. Masks should be worn and proper PPE should be worn. Any section being cleaned should be blocked off and clothes worn should be removed before entering into living space to help prevent mold spores from attaching into living spaces. See EPA website below for more information. <https://www.epa.gov/mold> It is normal for some fungal spores to be present in a normal indoor environment; however, no EPA regulations exist for safe air quality related to mold. Several agencies (EPA, CDC, OSHA) have guidelines for interpreting mold results, but have no threshold for quantity.

Task: New roof and mold remediation.

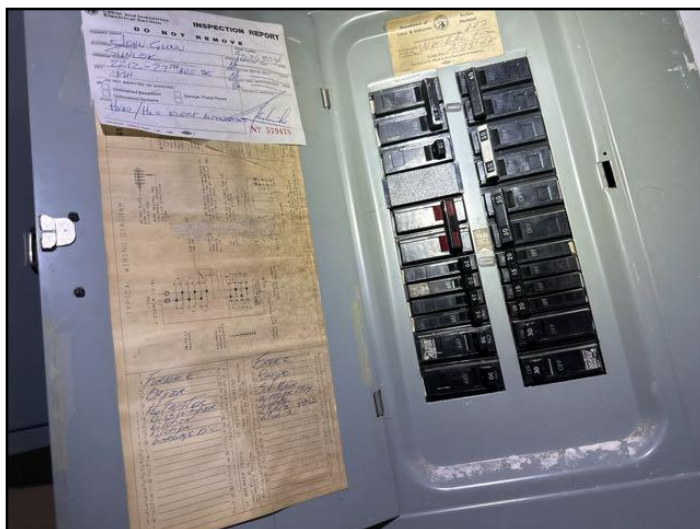
13.

Condition: • The labels and the breakers do not make sense amperage wise. Some of the wires for breakers are undersized or oversized for the breakers. Both panels have poor labeling

Task: Further evaluation by electrician and properly label or make corrections if needed

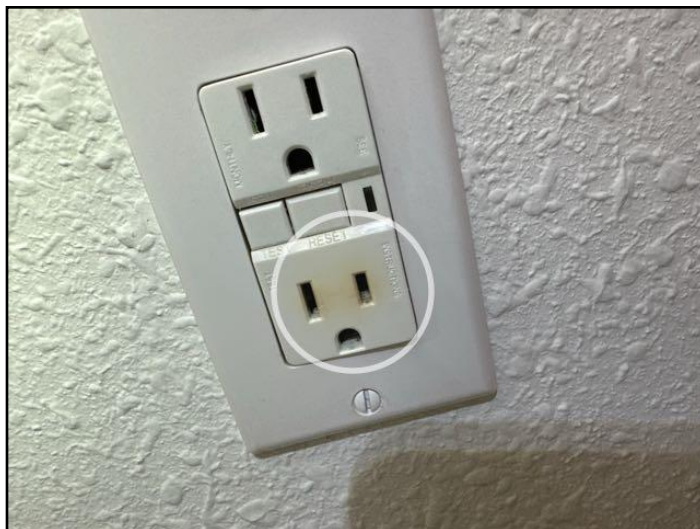
14.

Condition: • There are scorch marks from possible arcing at the receptacle

Location: Primary bedrooms bathroom receptacle

Task: Further evaluation by qualified professional recommended to repair or replace and correct issue as needed.

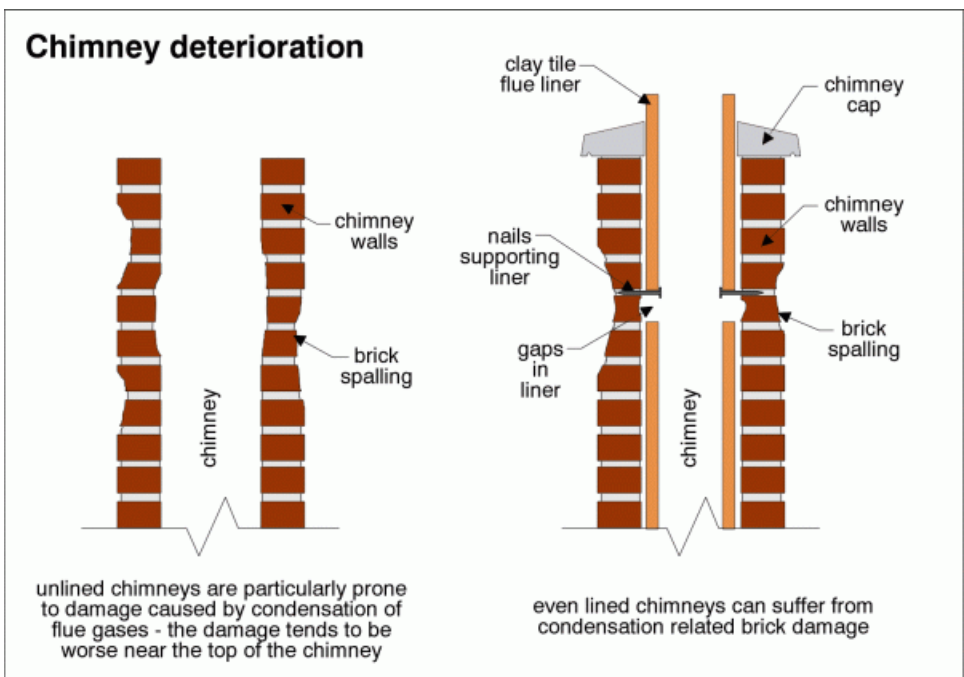
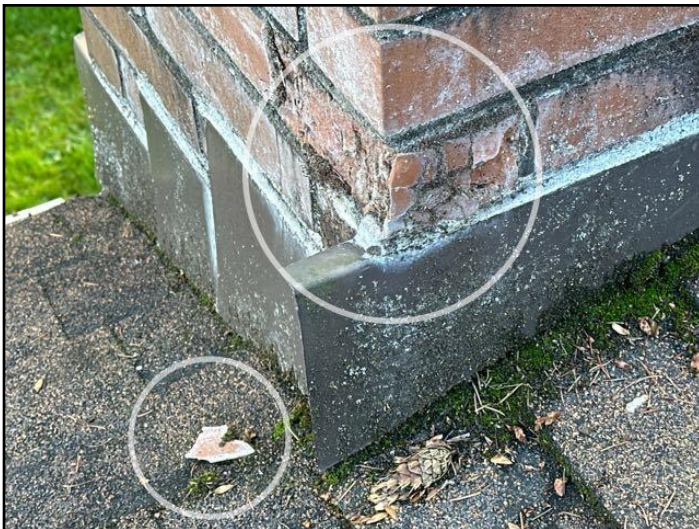
Condition: • [Loose, missing or deteriorated masonry](#)

Some bricks are breaking apart and parts of the chimney crown are deteriorating and leaving holes that could leak.

Task: Further evaluation by qualified professional recommended to repair or replace and correct issue as needed.

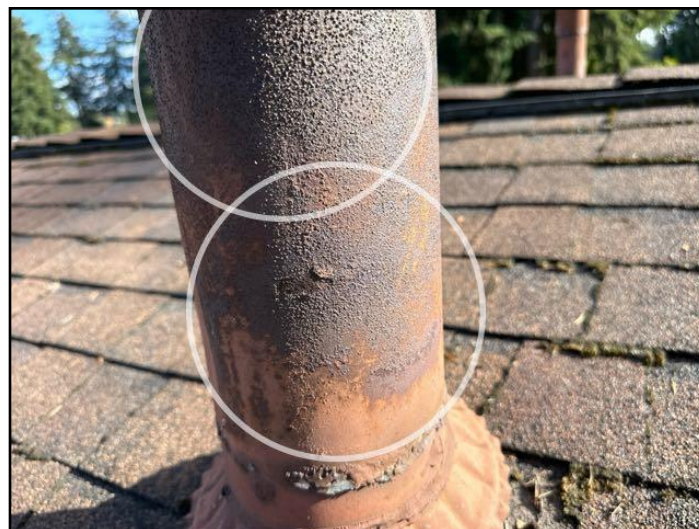
19. *Rust*

Condition: • Rust

The metal vent is heavily rusted and starting to flake apart

Task: Replace

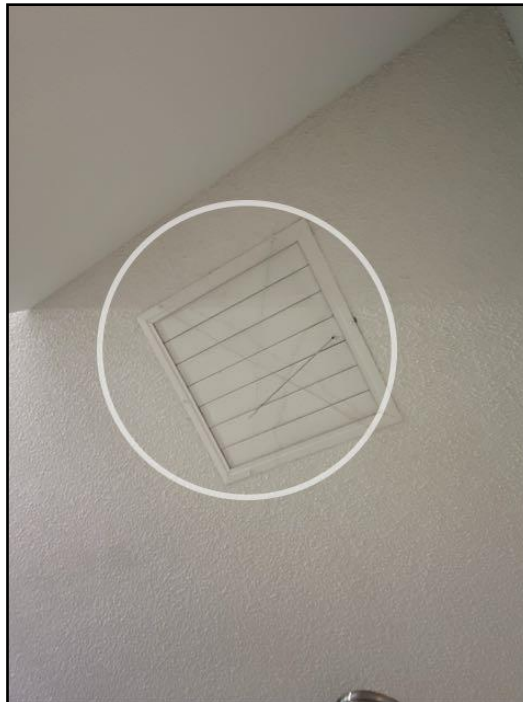
20.

Condition: • The whole house fan doesn't have any insulation or foam insulation attached. This can increase energy costs if not done. The fan also is extremely loud and sounds like something is loose or it's banging on the roof structure

Task: Further evaluation by qualified professional recommended to repair or replace and correct issue as needed.

Add insulation or replace part of the ceiling vinyl slats for a different type.

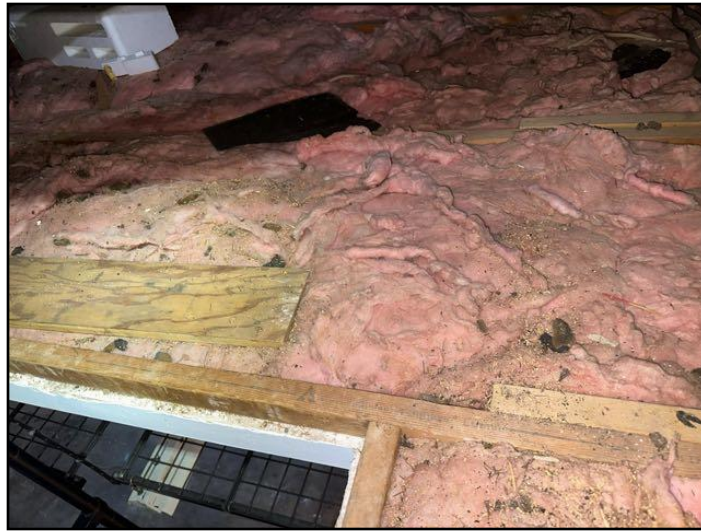
21. Animal/pest droppings in attic

Condition: • Animal/pest droppings in attic

Several dozens of animal droppings in attic. Pest droppings found in crawlspace and or attic. Pest droppings is a highly common thing to find. It does not mean there is a pest issue or isn't one. It is easy for pests to get into into any crawlspace without gaps on homes because they can get in from just digging under the foundation. Typically if they are getting into the crawlspace in older uninsulated walled homes, they can be getting into the attic as well. Steps are recommended to be taken to help prevent this issue which a pest professional should further evaluate the crawlspace. Crawlspace vents and areas around a crawlspace should be checked to help prevent pests. Measures may or may not have already been taken to correct this issue but a home inspection only notes on information visually provided during the time and day of inspection. Looking for signs including amount of droppings, insulation torn, and disturbed vapor barriers are helpful ways to identify the level of severity. Correcting any damages, as well as cleaning any droppings and replacing damaged insulation is recommended. Home inspectors are not pest professionals and always recommend further evaluation. Having a pest service once a year is a great way to help prevent issues. Please see EPA guidelines link for more information.

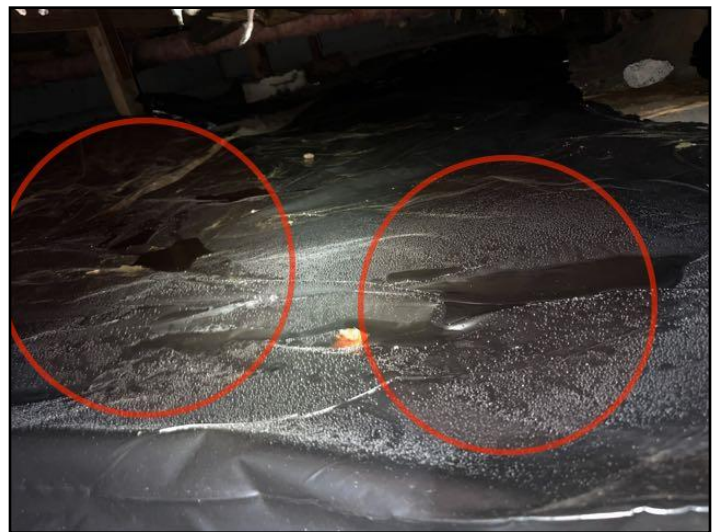
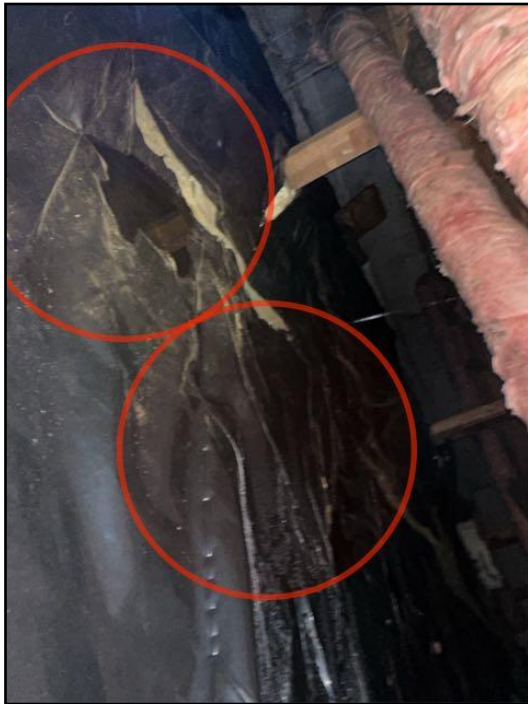
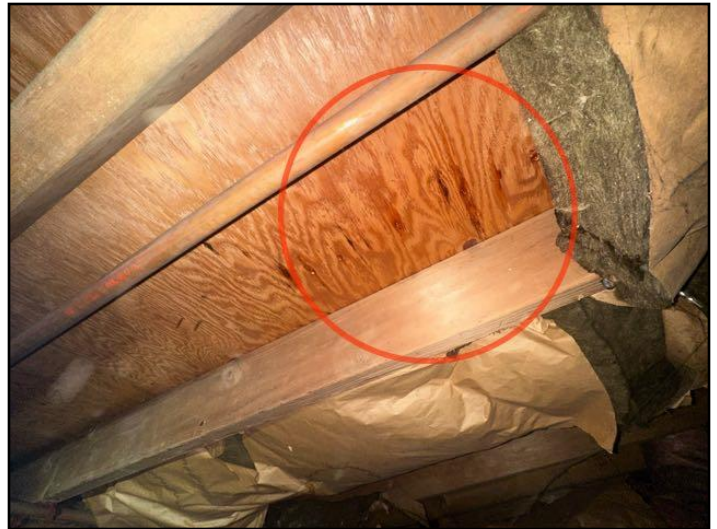
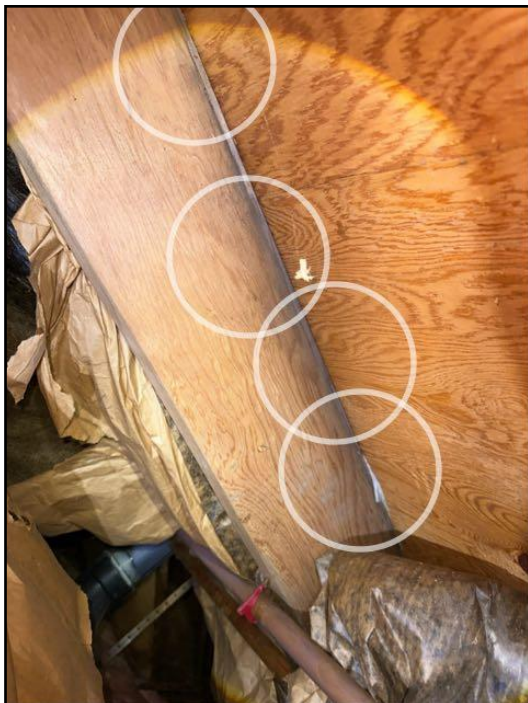
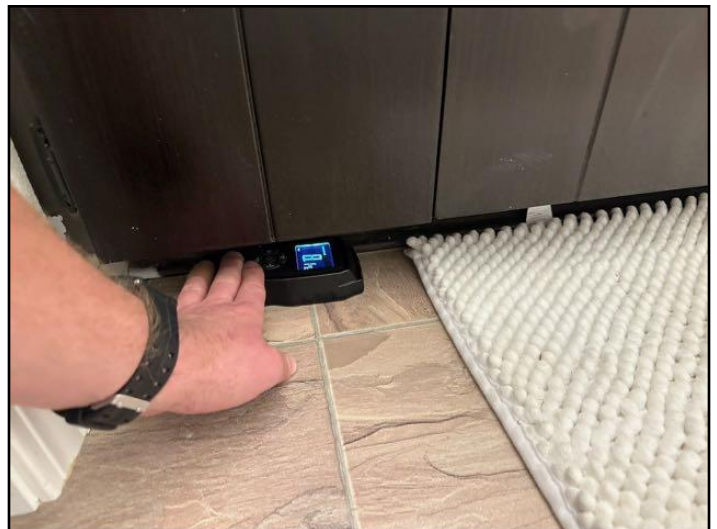
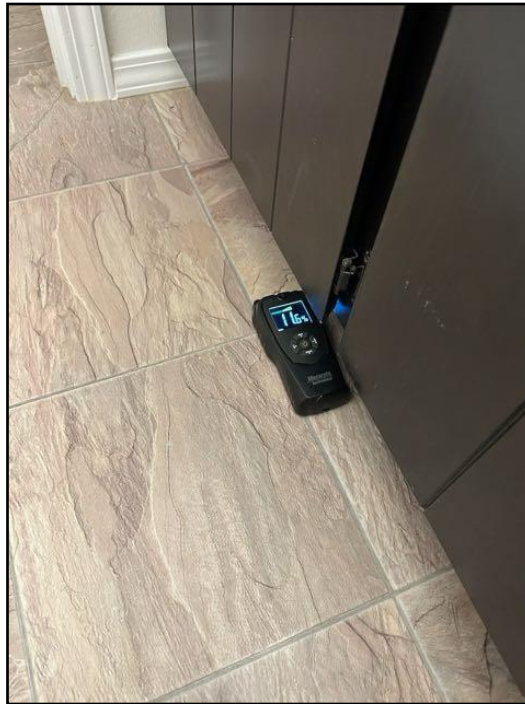
Condition: • There are several leaks in the crawlspace, some near the bathrooms, some under, and some closer to the hall. There is signs of water staining on the floor joists which may indicate this has been going on a while. The sub flooring is saturated with moisture and is shown on the laminate flooring in the bathroom. Most of the moisture appears to be under the sink cabinet.

Task: Further evaluation by qualified professional recommended to repair or replace and correct issue as needed.

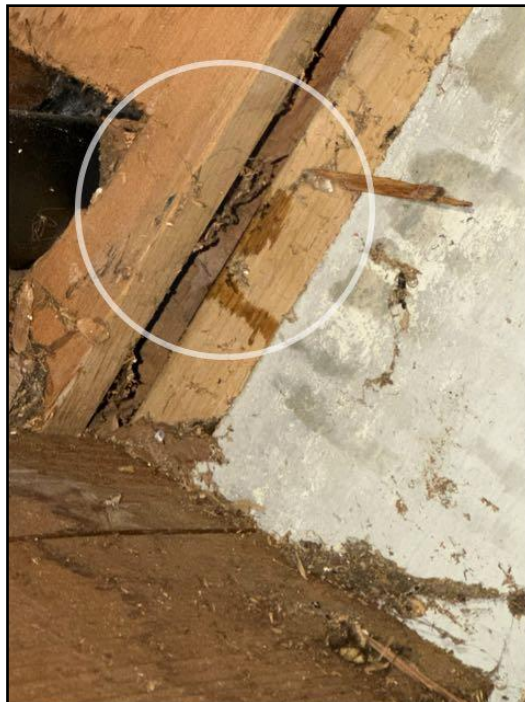
29.

Condition: • Leak u see kitchen sink cabinet with water staining

Task: Further evaluation by qualified professional recommended to repair or replace and correct issue as needed.

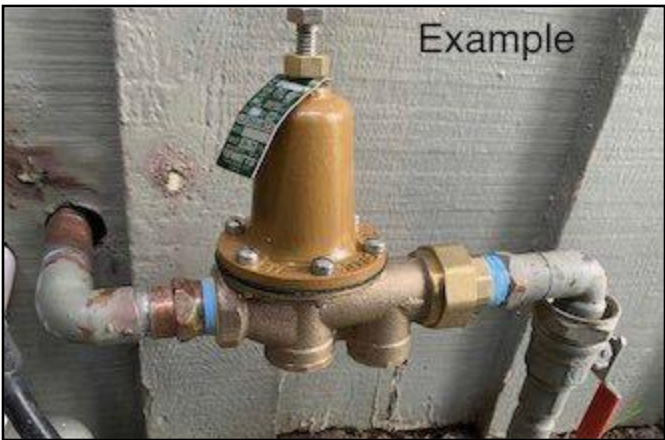
33. Recommended due to high supply water...

Condition: • Recommended due to high supply water pressure

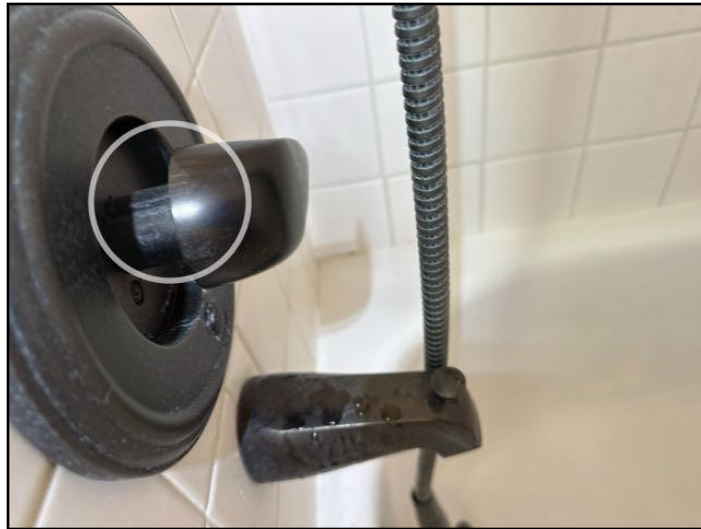
38.

Condition: • The hall shower would not work during inspection. I was unable to inspect the plumbing for leaks

Task: Further evaluation by qualified professional recommended to repair or replace and correct issue as needed.

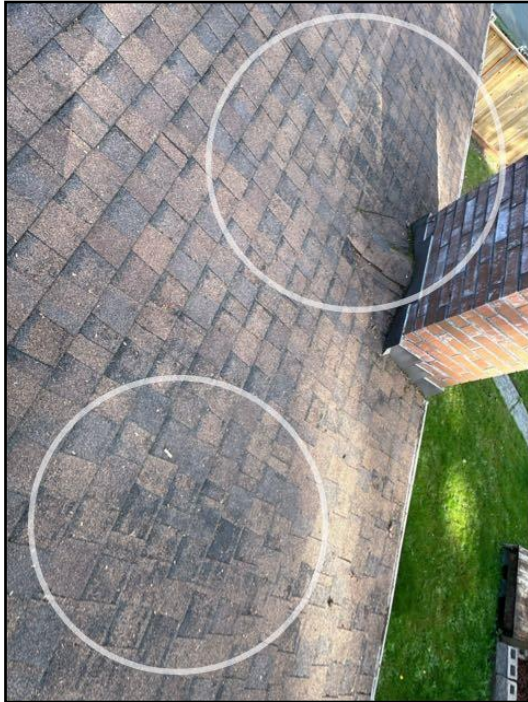
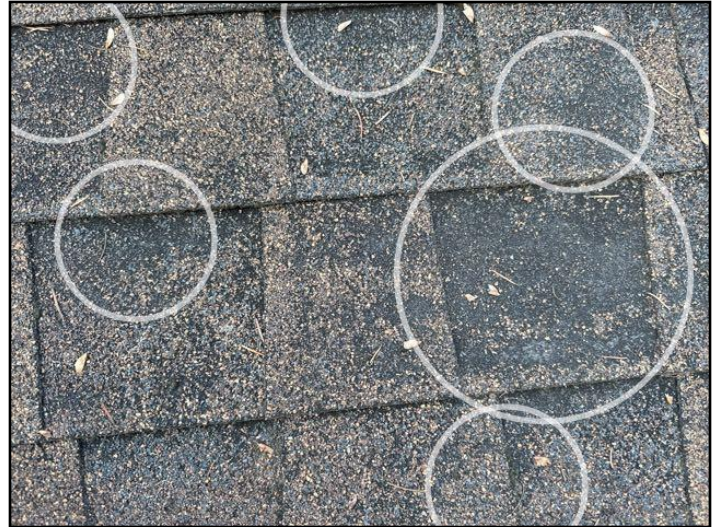
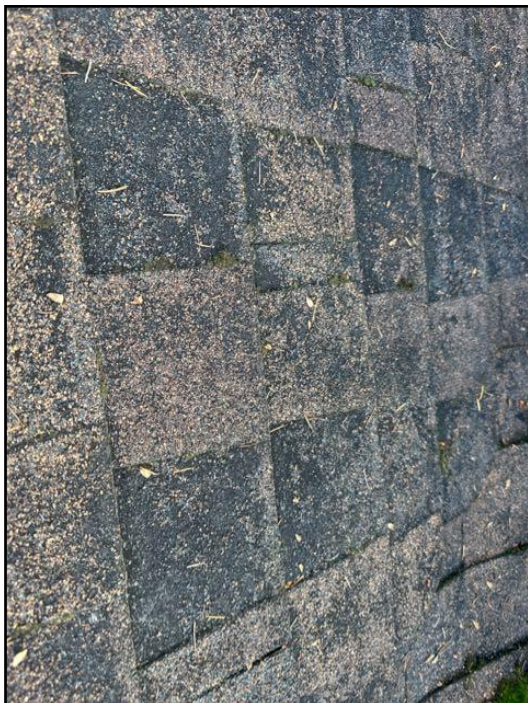
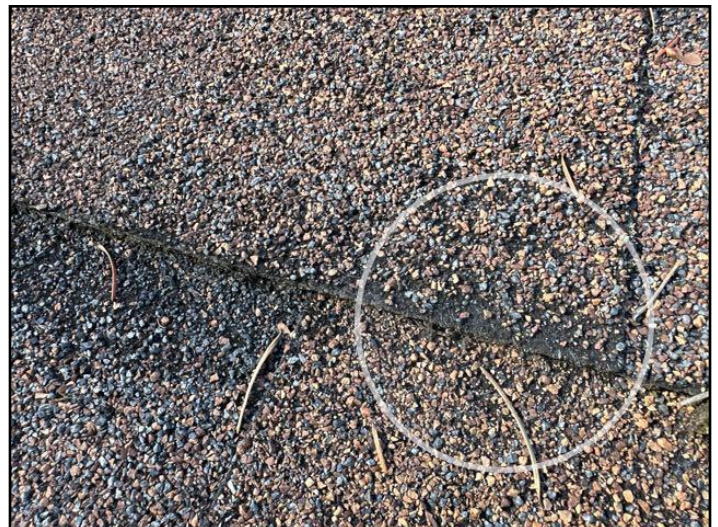
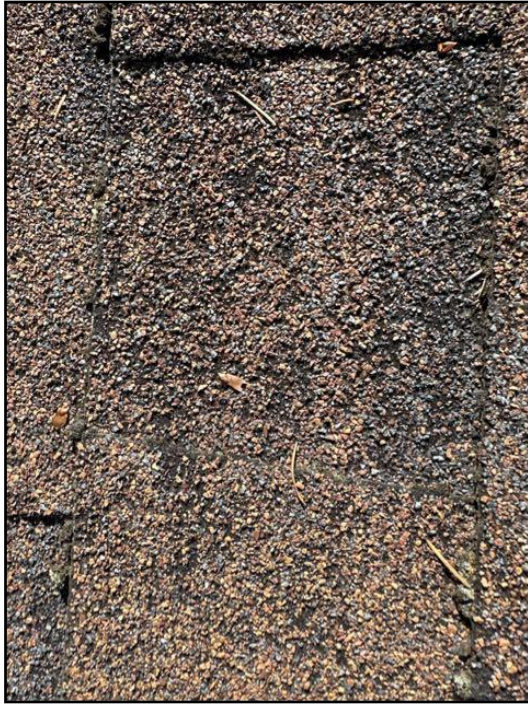
Condition: • [Granule loss](#)

Severe granule loss on the southern side and mostly near the chimney. Some shingles have less than 10% of granules left. While walking on the roof more granules were slipping off. Most of the southern side has medium to heavy granule loss. Granule loss happens as roofs get older and they start separating from the shingles. It is a way to help gauge how much older a roof is getting and one of the most common things roofs experience during the aging process. When granules on the roof start to feel slippery, have high amounts missing, or are developing high amounts of granules in the gutters, then the roof is likely past its life expectancy and leaking. A roofer would be needed to help try and predict how much life is left before leaks and moisture can develop in the attic. Architectural shingles typically have an average life span of 25 years, 3-tab shingles approximately 20 years, and residential shingles around 30 years. The life expectancies vary by many factors. Some of them are quality of product, quality of installation, weather and season patterns, and upkeep. Extreme heat events that last longer than usual can cause the shingles to dry up the asphalt, crack, and lose some of its life expectancy. Moss on roofs is very common and without treating and removing it can reduce the life expectancy. Moss usually grows on Northern portions of roofs and more often near trees. Moss can grow or regrow on roofs sometimes in just a year and typically is not a factor in gauging the condition or age of the roof. The Southern parts of the roof usually catch the brunt of weather and can deteriorate quicker than other parts.

Task: Replace roof and remediate attic droppings and organic growth

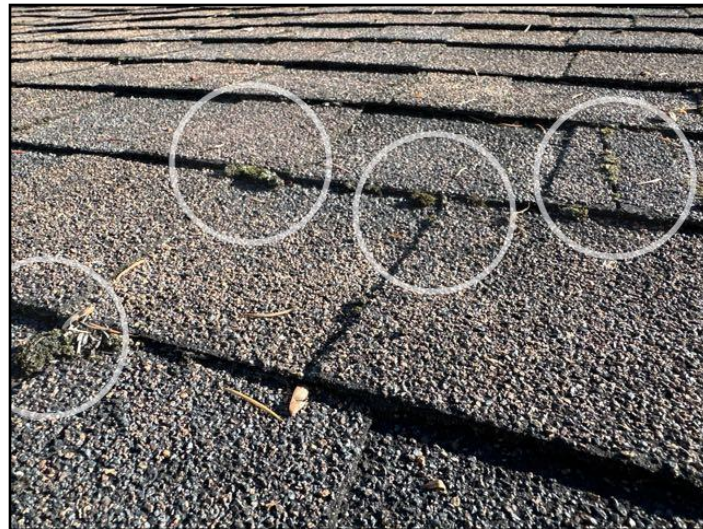
51. Debris/moss

Condition: • Debris/moss

The roof appears to have been recently cleaned but there is still moss on the roof

Task: Have cleaned. No pressure washing or metal brush

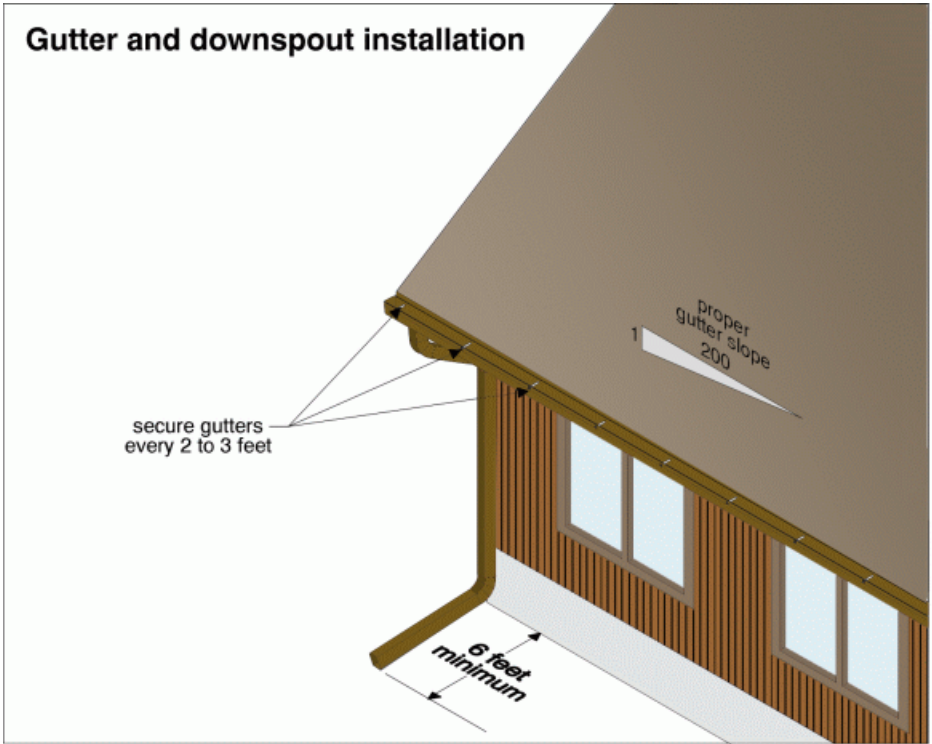
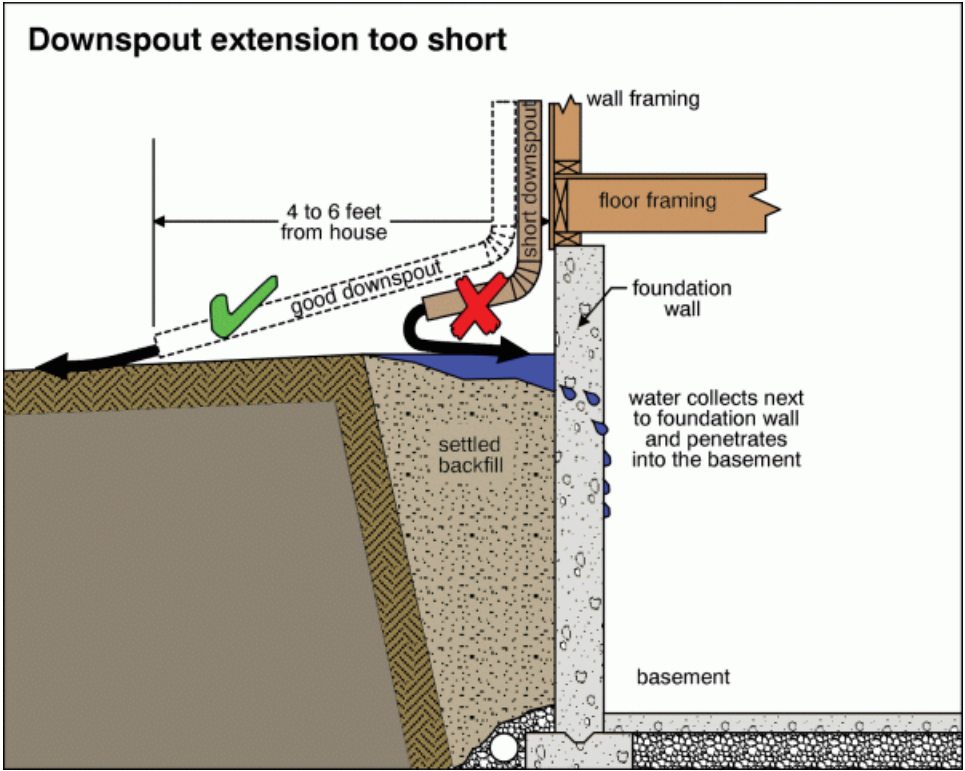
55. Discharge too close to building

Condition: • [Discharge too close to building](#)

Task: Extend

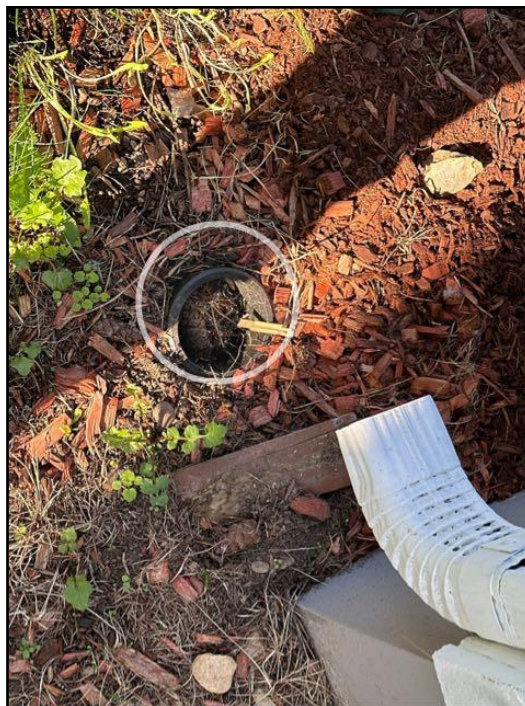
56.

Condition: • The underground storm drain system is clogged and no longer in use

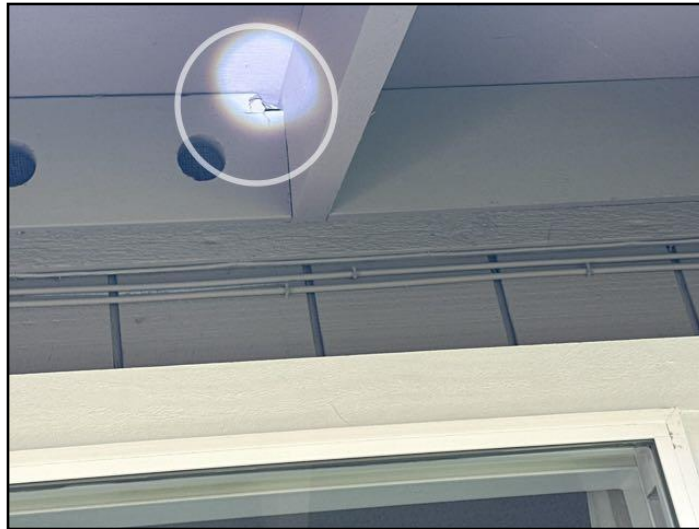
57.

Condition: • Small gap at back eaves should be sealed to help prevent insects or pests

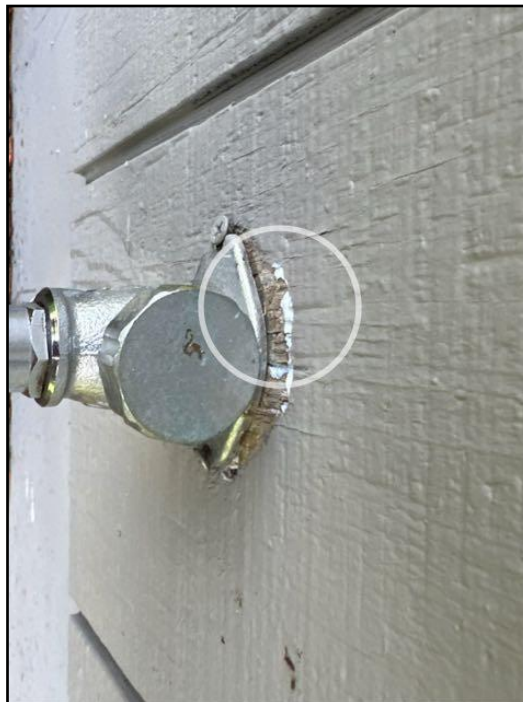
Condition: • Paint missing around hose bib

Task: Provide

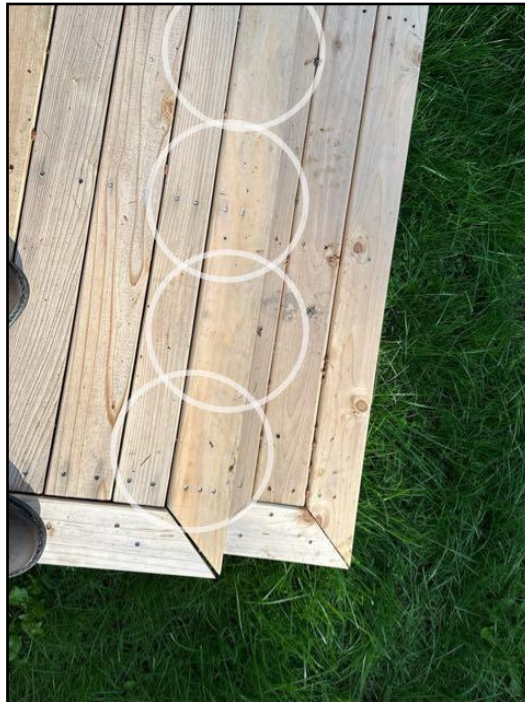
62. Loose deck board

Condition: • Loose deck board

Task: Repair or replace

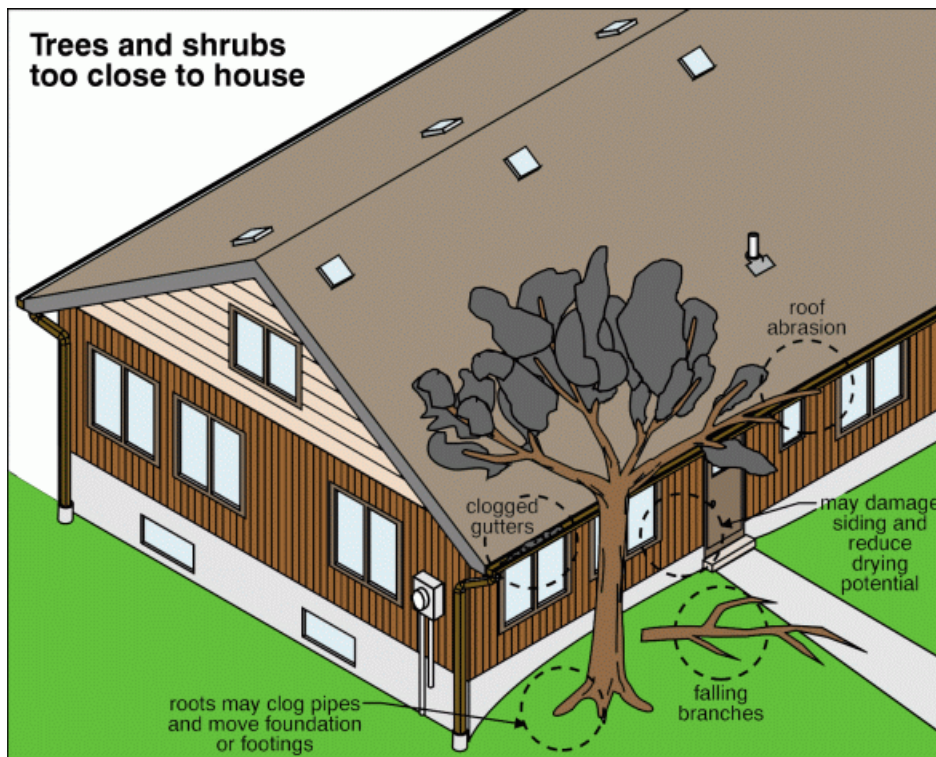
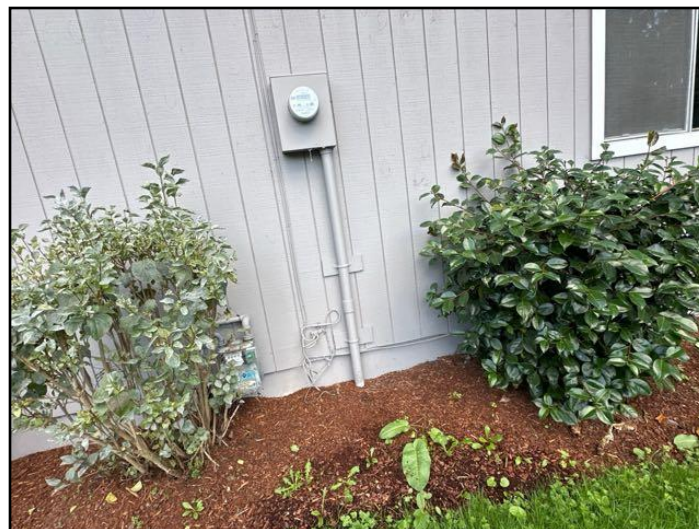
64. Trees or shrubs too close to building

Condition: • [Trees or shrubs too close to building](#)

Trees and shrubs when too close or in contact could potentially allow insects into walls or cause damage to the siding finishings and the roof.

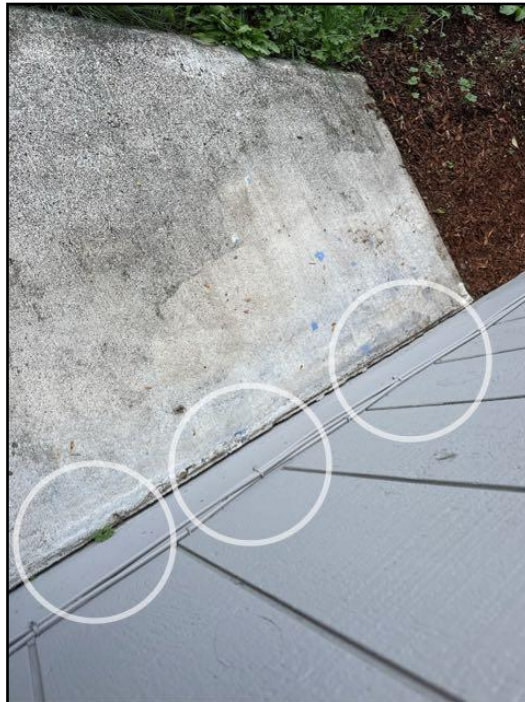
66. *Unsealed gap at building*

Condition: • Unsealed gap at building

Task: Seal

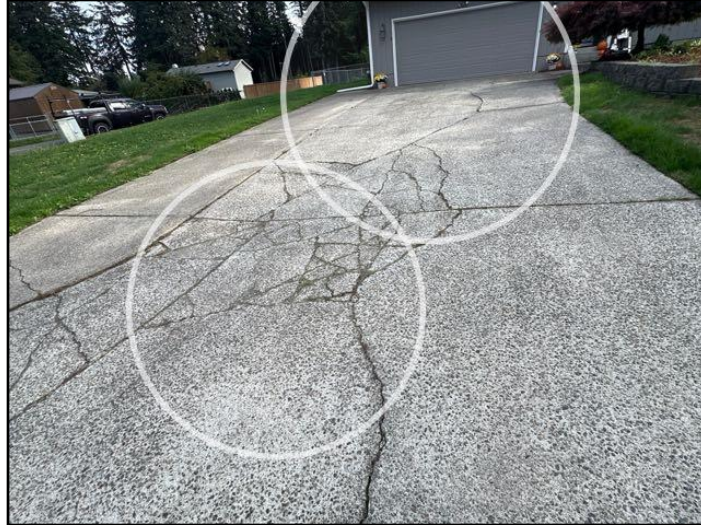
67. Cracked or damaged surfaces

Condition: • [Cracked or damaged surfaces](#)

Settling cracking in driveway. Settlement cracking in walkways, driveways, concrete patios, and garages is very common. Sealing the cracks can typically help with preventing future erosion. Concrete caulking can usually be used to do this and

adding small pebbles or sand to the caulk can leave a nicer appearance. If the cracking is more significant causing uneven trip hazards or major slopes where ponding can occur, a slab jack service may need to be done.

Location: Driveway and walkway in back of house

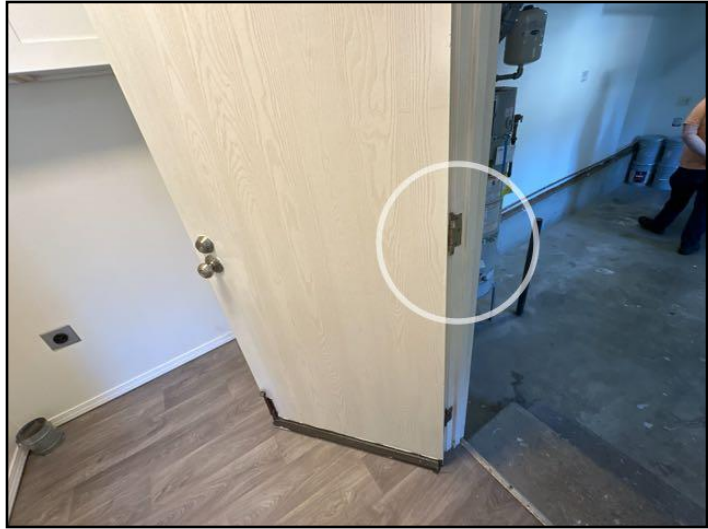
69. *No self-closer*

Condition: • [No self-closer](#)

Task: Replace and adjust

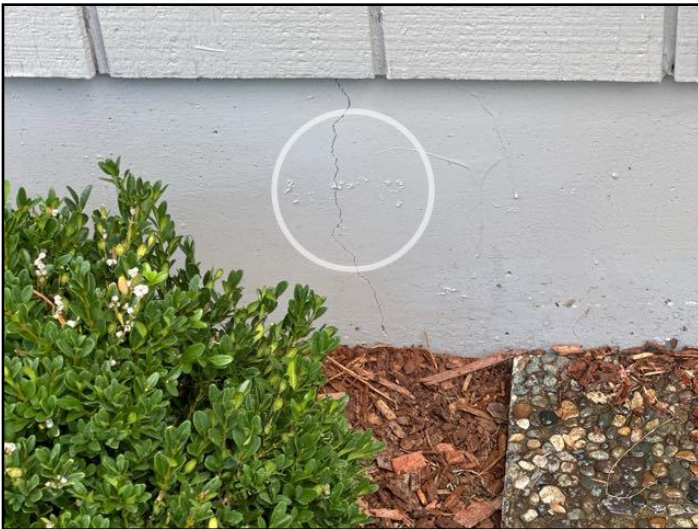
83. Typical minor cracks

Condition: • Typical minor cracks

Typical minor foundation cracks. Foundation cracking is extremely common even in brand new homes. Poured concrete shrinks during the curing process, which usually results in small cracks. Cracking usually doesn't need to be addressed unless they are more significant, have specific angles, and there is evidence of continuous movement. If the cracks are wide enough, water can sometimes seep through and get into a crawlspace or basement. In these situations they should be sealed from the outside. Cracks wider than 1/4 inch should always be evaluated by a structural contractor.

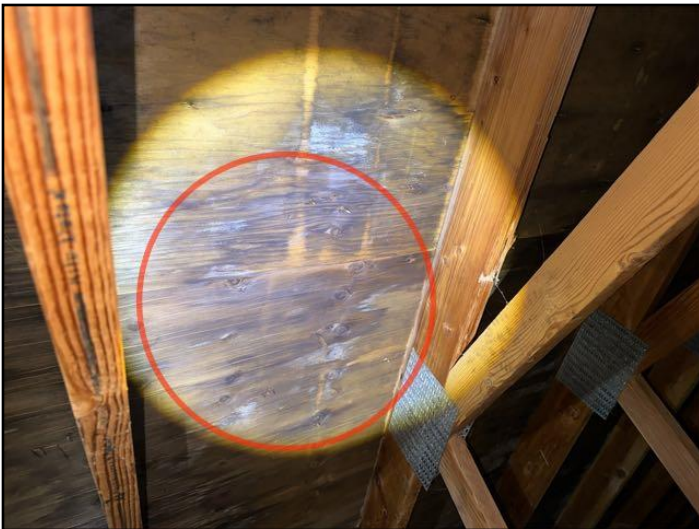
85. Water stains

Condition: • [Water stains](#)

Water stains and organic growth found throughout attic. There are signs that the water stains are leaks and leaking into the insulation. Thermal imaging found dozens of spots where the sheathing was cold and had water stains. I tested the For moisture and had high levels. I tested another spot without water stains for moisture as a control and it was more than half as much moisture. All of these signs and the condition of the shingles indicate the roof is leaking and past its life expectancy.

Fungus growth is a common thing to find in the Pacific Northwest due to its climate. Presence of mold should be tested for which type and whether it is hazardous or not. A mold remediation company should be contacted for further evaluation and to do proper remediation. These companies have special skills and practices that ensure the proper procedures are done. There are multiple types of remediation including removing the mold from the area and fogging. Methods applied to correct a mold issue depends on where, severity of quantity, and the type of mold. Common causes of mold in attics are roof leaks, improper attic ventilation, or a disconnected vent from a moist area IE bathrooms and kitchens. Occasionally when newer homes are built the wood materials are wet from outside storage and the growth occurs during the construction process. The cause for the mold should be addressed when attempting remediation or the problem may persist. Applying a mold resistant primer will not kill the mold and merely will hide it. If attempting to correct a mold issue yourself please read the labels on the product and look for mold killer not mold resistant. Dead mold may still affect someone with allergies. If attempting to remove and clean mold yourself, dish soap is a good way to scrub it off, bleach can help kill anything left, and mold prevention primer can help prevent it. Masks should be worn and proper PPE should be worn. Any section being cleaned should be blocked off and clothes worn should be removed before entering into living space to help prevent mold spores from attaching into living spaces. See EPA website below for more information. <https://www.epa.gov/mold> It is normal for some fungal spores to be present in a normal indoor environment; however, no EPA regulations exist for safe air quality related to mold. Several agencies (EPA, CDC, OSHA) have guidelines for interpreting mold results, but have no threshold for quantity.

Task: New roof and mold remediation.

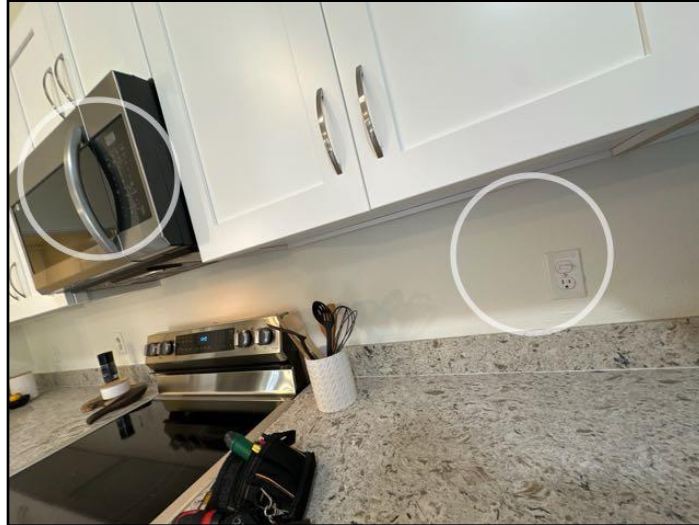
91.

General: • This switch turns off the microwave.

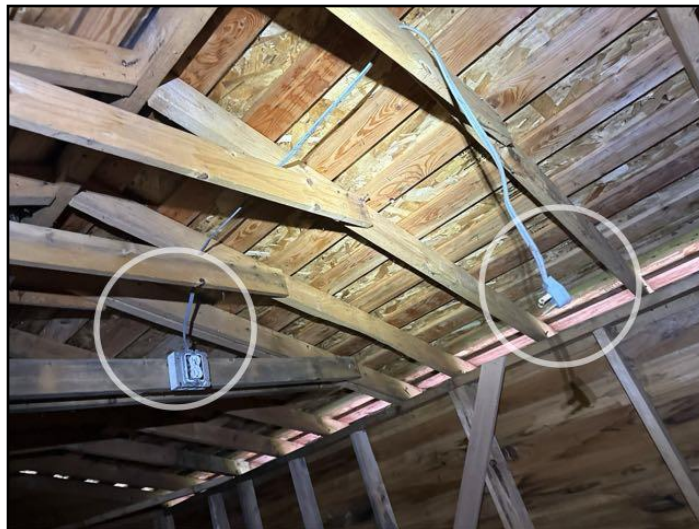
92.

General: • Not sure what the wires for the shed are for.

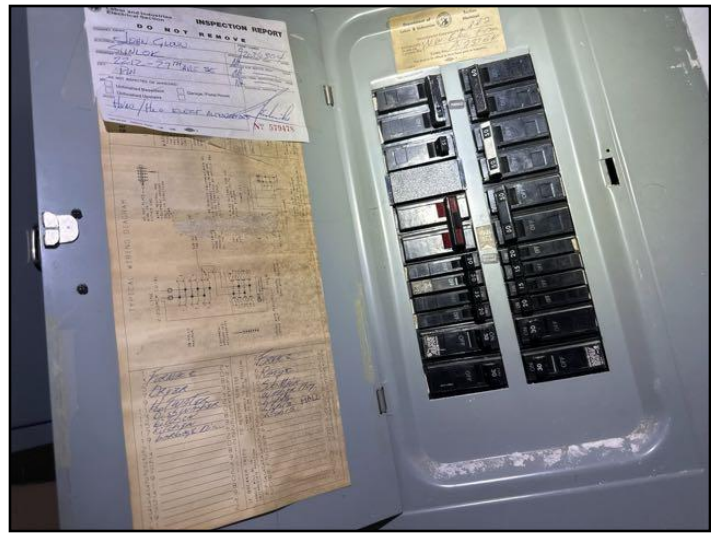
96.

Condition: • The labels and the breakers do not make sense amperage wise. Some of the wires for breakers are undersized or oversized for the breakers. Both panels have poor labeling

Task: Further evaluation by electrician and properly label or make corrections if needed
