INSPECTION REPORT

For the Property at:
1234 INSPECTION STREET
PUYALLUP, WA 98374

Prepared for: BUYER .
Inspection Date: Wednesday, October 9, 2024
Prepared by: Chad Fletcher

RE: Report No. 1616, v.0
1234 inspection street
Puyallup, WA
98374

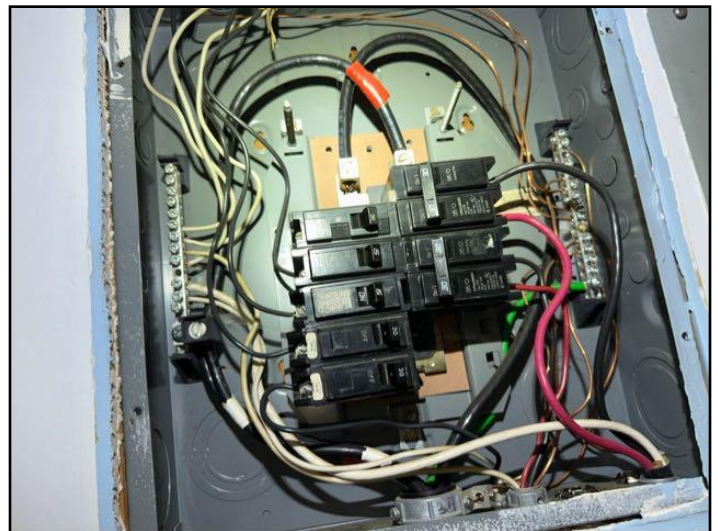
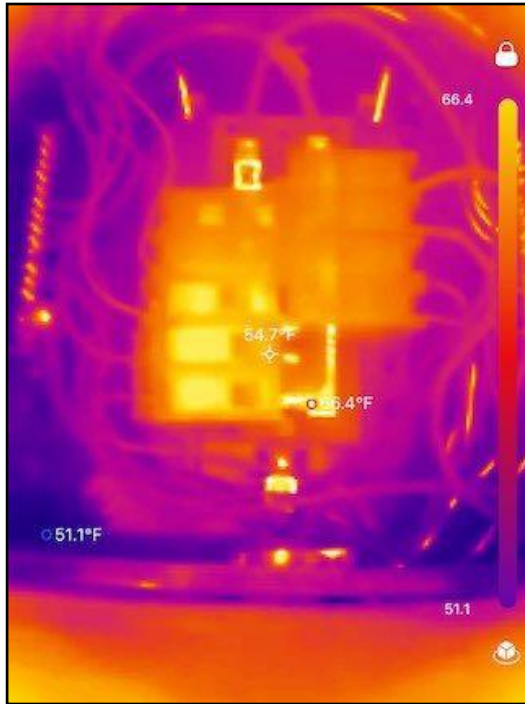
Condition: • Picture of sub panel. No overheating found

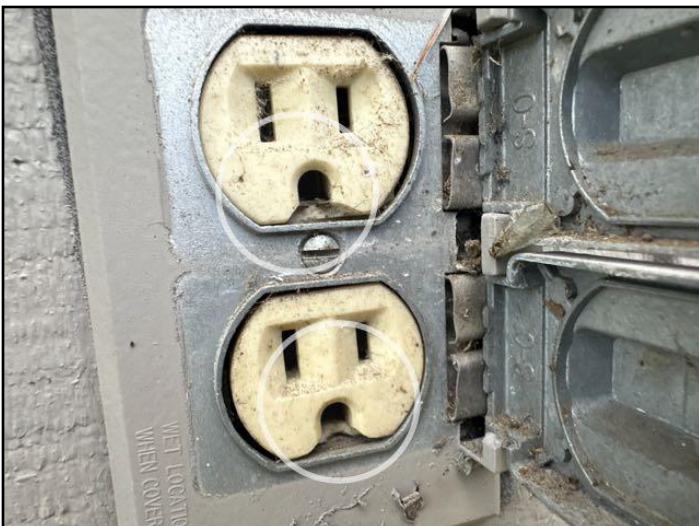
100. Damage

Condition: • [Damage](#)

Damaged receptacles should be replaced and are typically older. Older receptacles and some cheaper quality types will often experience issues especially in activity areas including but not limited to bedrooms, kitchens, and often exterior receptacles are common to have damage. Over time they become loose, grounding slots can get damaged, and plugs won't sit snug inside. All these issues can become safety issues, can loosen wires and possibly cause other issues including arcing. Furniture and storage can sometimes limit the inspection. When any of these conditions are apparent I recommend having a licensed electrician evaluate all receptacles for any issues and repair or replace as needed.

Location: Front exterior, back exterior, garage receptacles

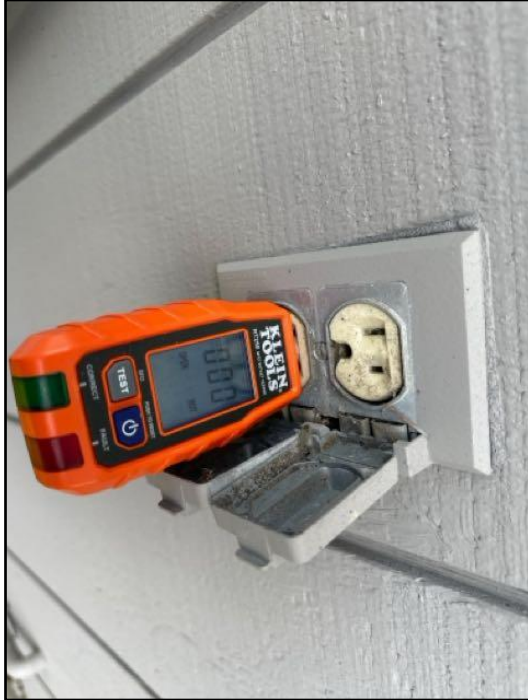
102. Inoperative

Condition: • [Inoperative](#)

Location: Front exterior, side exterior. The garage GFCI won't reset so may be because of that

Task: Further evaluation by qualified professional recommended to repair or replace and correct issue as needed.

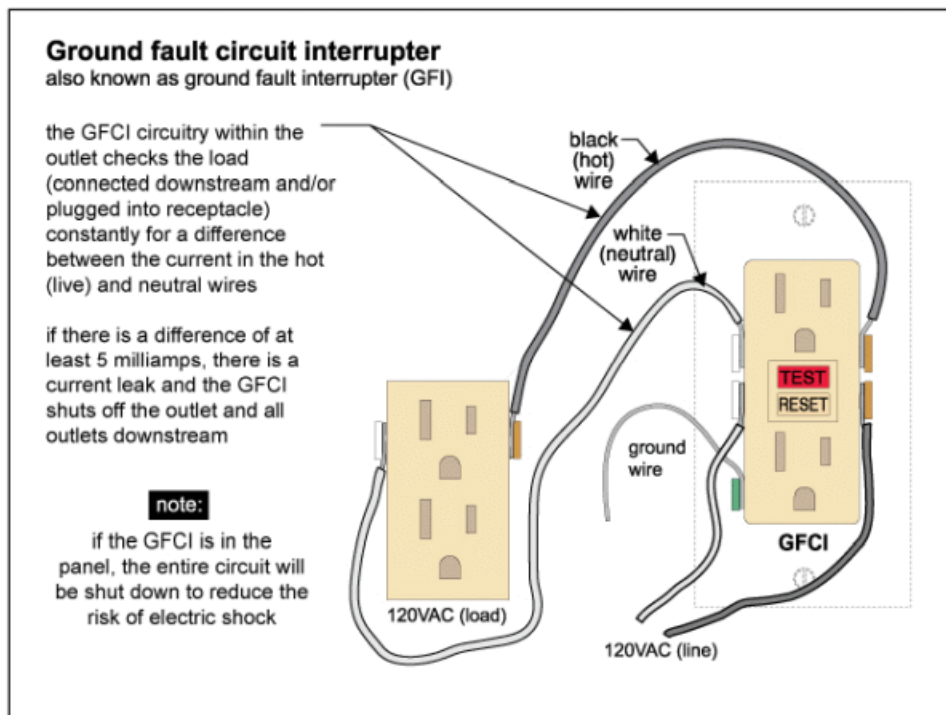
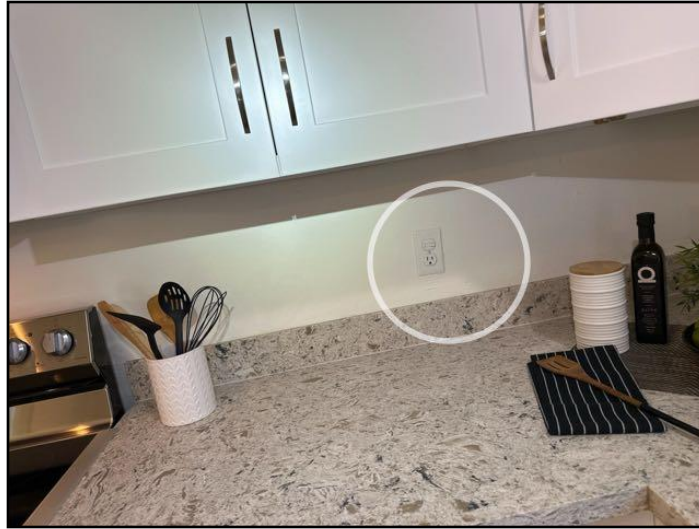
105. No GFCI/GFI (Ground Fault Circuit...

Condition: • [No GFCI/GFI \(Ground Fault Circuit Interrupter\)](#)

GFCI's are recommended in all wet locations. These devices provide protection from shock hazards. If they are missing they should be installed as soon as possible for safety. Not all required outlets will need the test button, as long as it is downstream of a gfcf outlet. See link for more information. <https://apps.leg.wa.gov/wac/default.aspx?cite=296-46B-210>

Location: Back exterior, kitchen counter, some garage receptacles

Task: Provide

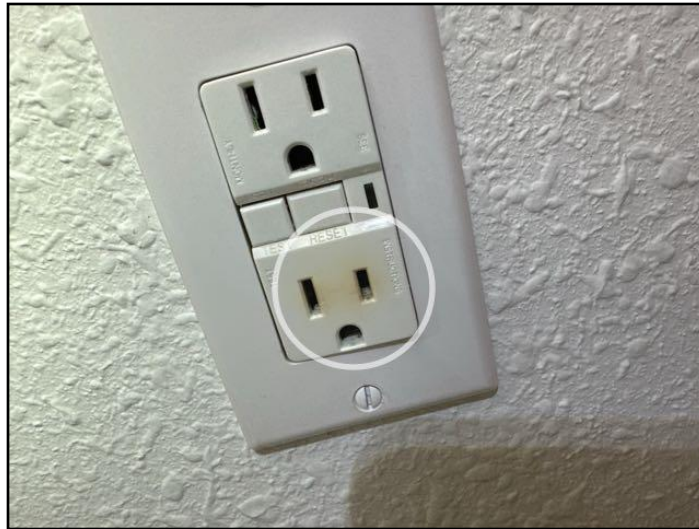
106.

Condition: • There are scorch marks from possible arcing at the receptacle

Location: Primary bedrooms bathroom receptacle

Task: Further evaluation by qualified professional recommended to repair or replace and correct issue as needed.

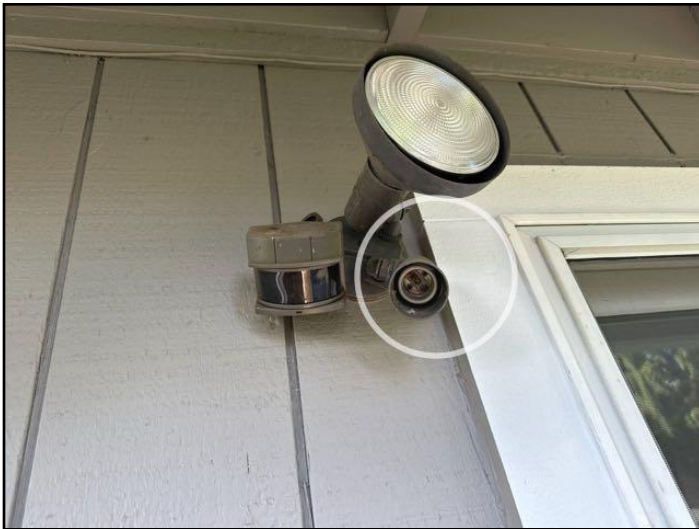
107. Inoperative

Condition: • [Inoperative](#)

Lights that are inoperative are typically from burned out bulbs. However, there isn't a way of knowing for sure unless the bulb is replaced. If the bulb is at the exterior it may be a motion sensor or light sensor fixture . If the bulb is replaced and still doesn't work it could be from faulty wiring or damage to the fixture and further evaluation would be needed by a licensed electrician.

Location: Missing back porch bulb, front porch

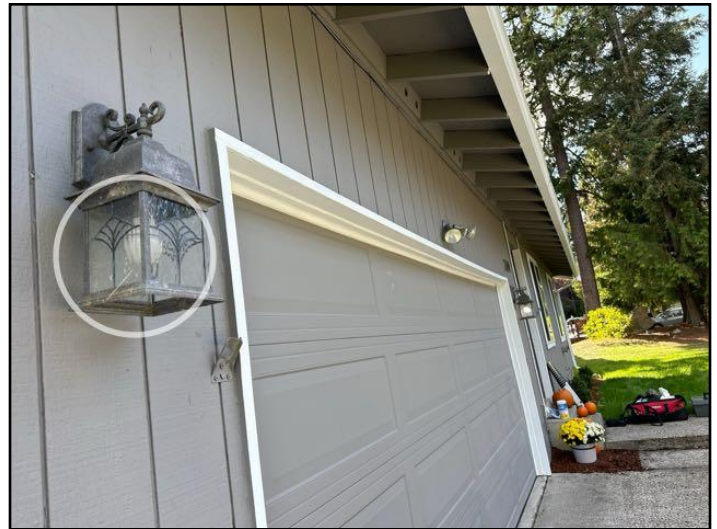
108. Inoperative

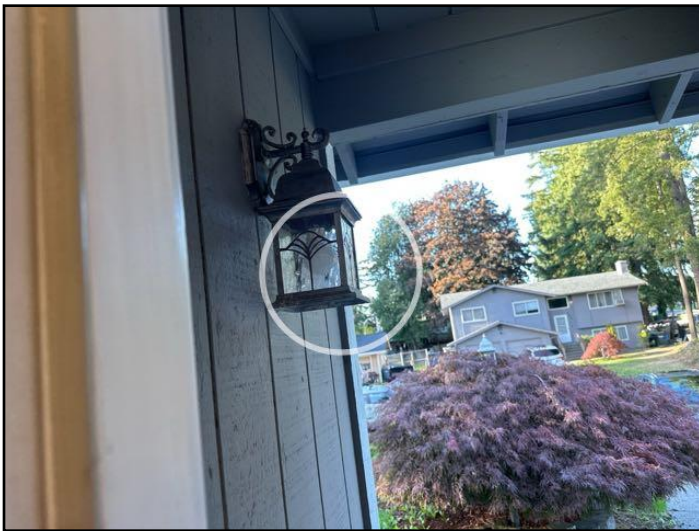
109. Inoperative

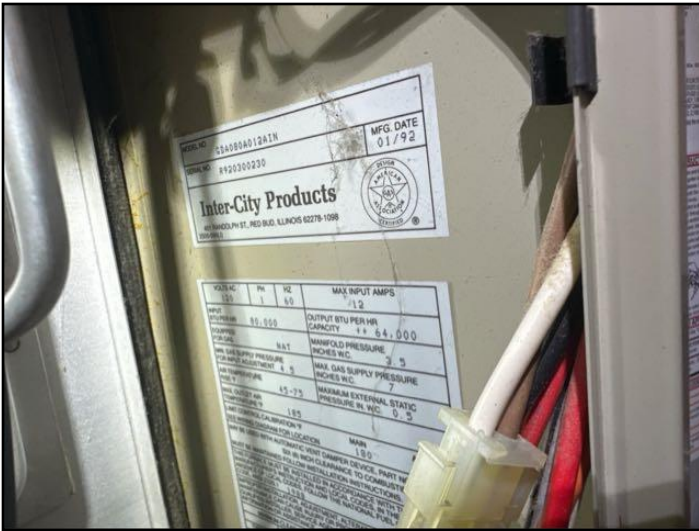
Condition: • [Old](#)

1992 furnace. Whenever heating and cooling systems are older than 5 years old or near the end of its life expectancy, I always recommend servicing and further evaluation by a licensed HVAC tech to run additional tests. Repairs can typically be made but eventually as heating and cooling systems become too old they may need to be replaced.

113. Old

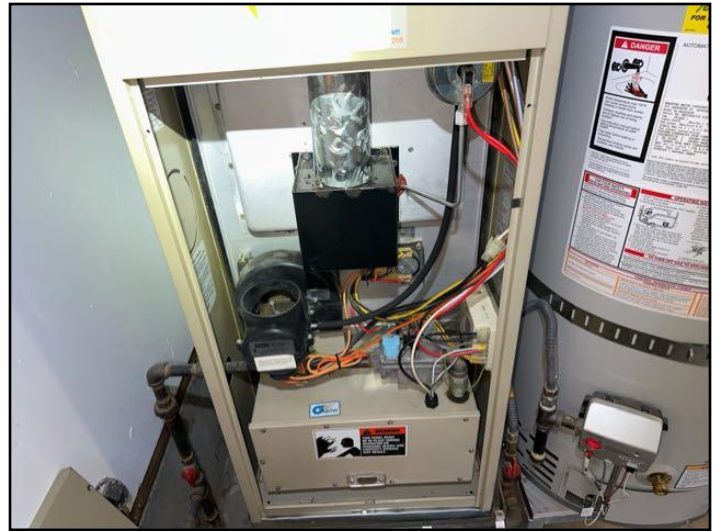
114. Old

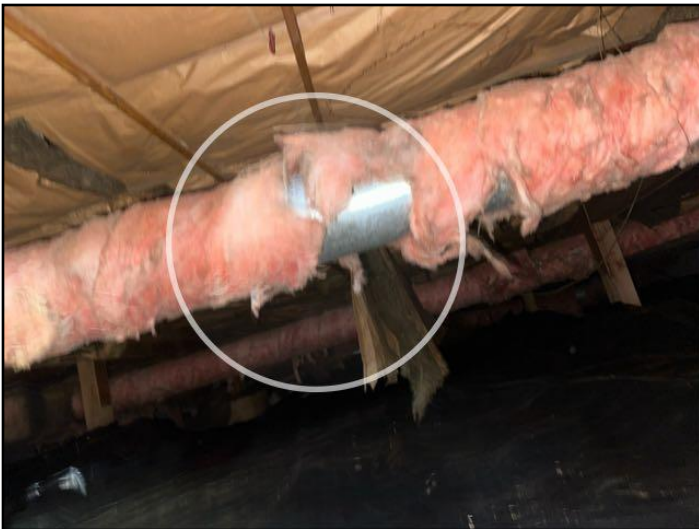
Condition: • [Insulation missing, damaged](#)

Location: Various spots in crawlspace

115. Insulation missing, damaged

Task: Repair/replace

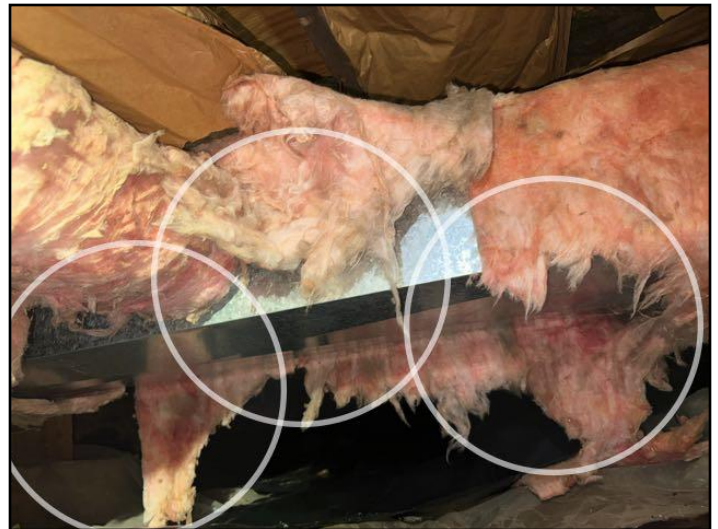
116. Insulation missing, damaged

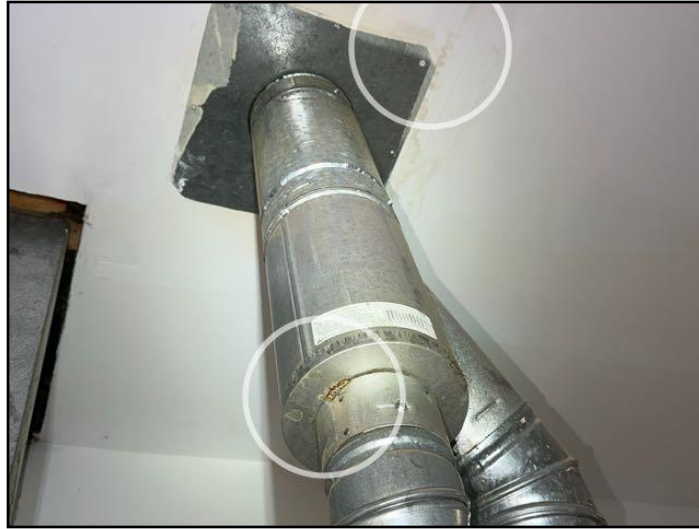
117.

Condition: • The venting system is showing signs of rusting with water staining

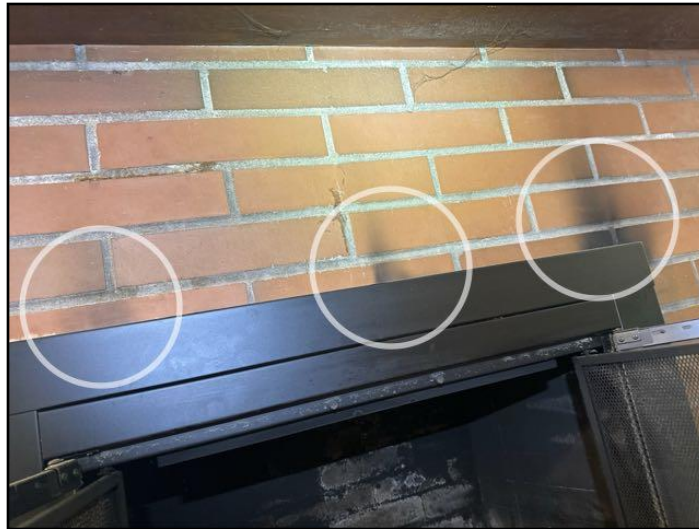
118.

Condition: • Signs of possible backdrafting. A damper is a possible cause of it.

Task: Further evaluation by qualified professional recommended to repair or replace and correct issue as needed.

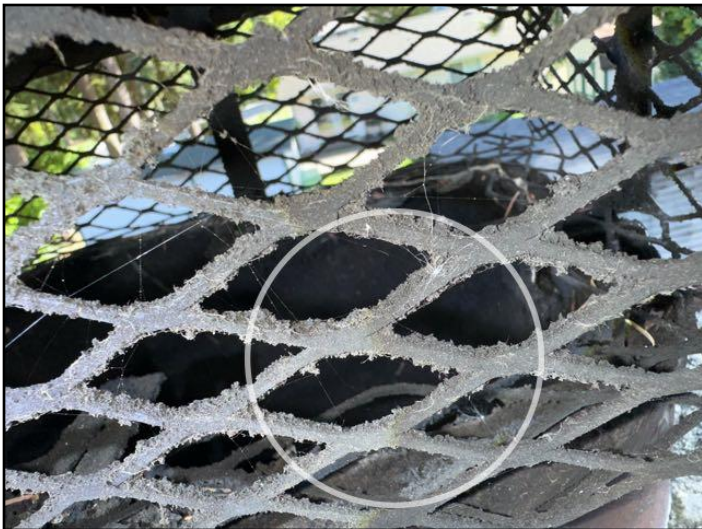
Condition: • [Creosote build-up](#)

119. Creosote build-up

Task: Recommend having cleaned/swept before use.

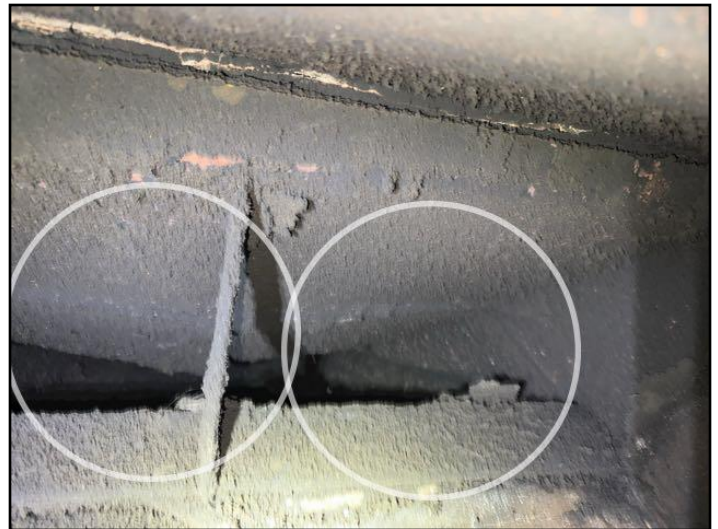
120. Creosote build-up

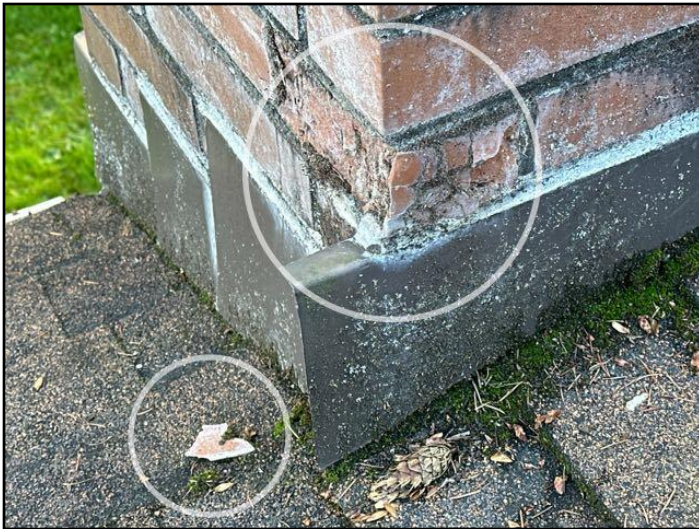
Condition: • [Loose, missing or deteriorated masonry](#)

Some bricks are breaking apart and parts of the chimney crown are deteriorating and leaving holes that could leak.

121. Loose, missing or deteriorated masonry

Task: Further evaluation by qualified professional recommended to repair or replace and correct issue as needed.

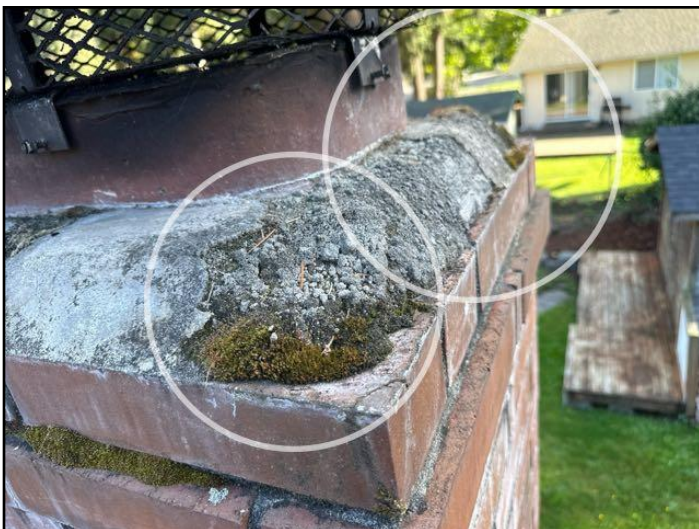
123. Loose, missing or deteriorated masonry

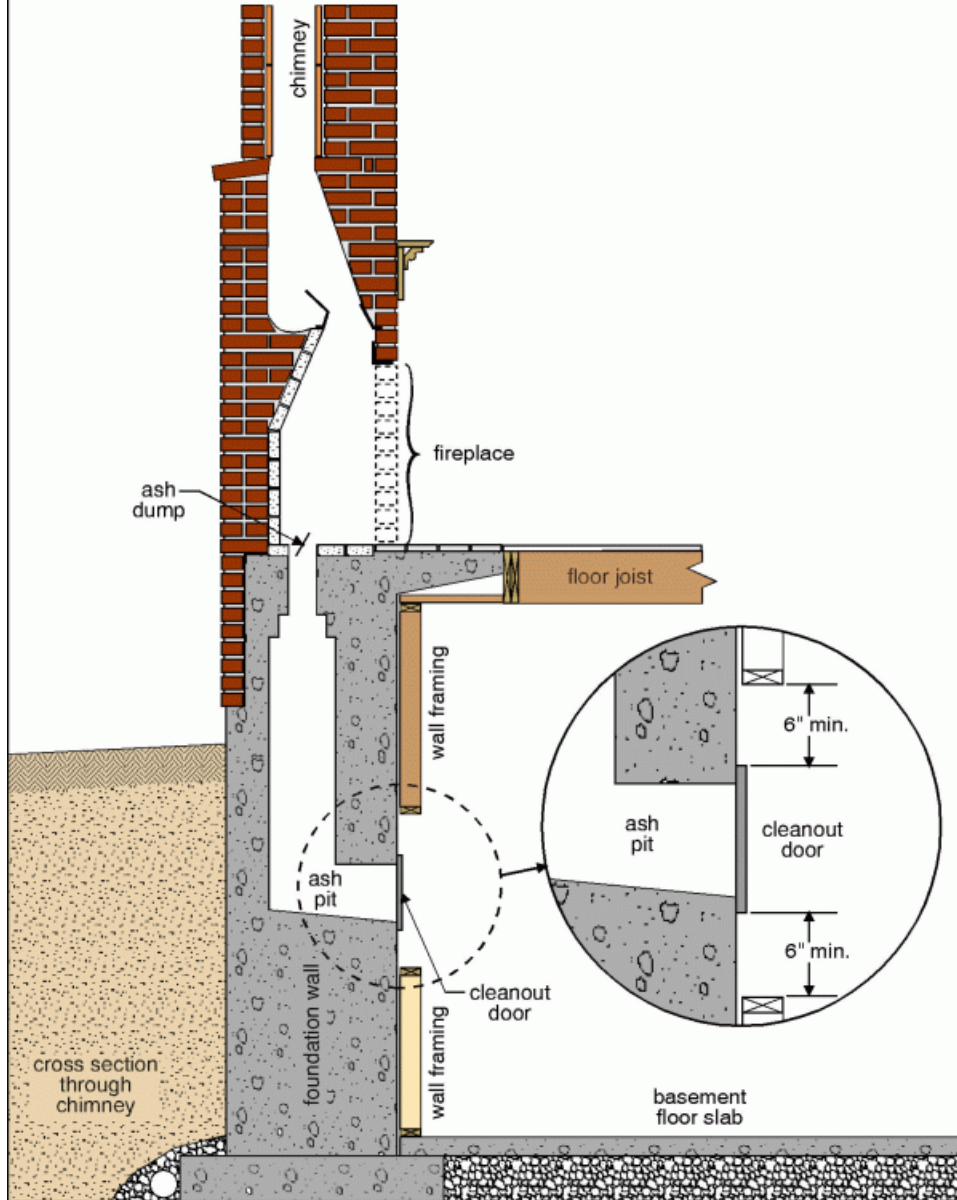
Fireplace cleanout - door too close to combustibles

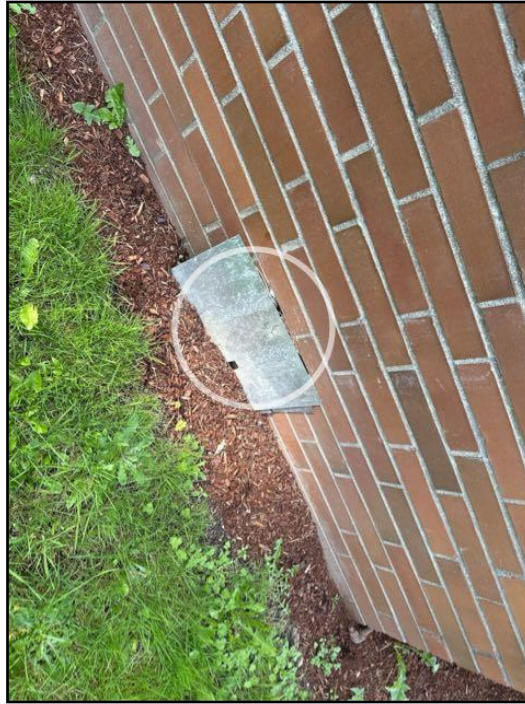
Condition: • [Cleanout door missing](#)

127. Cleanout door missing

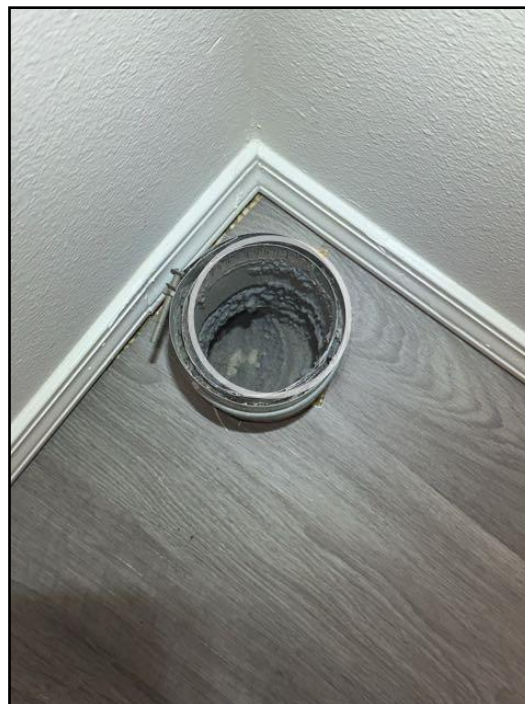
128.

Condition: • The dryer vent has lint build up

Task: Clean

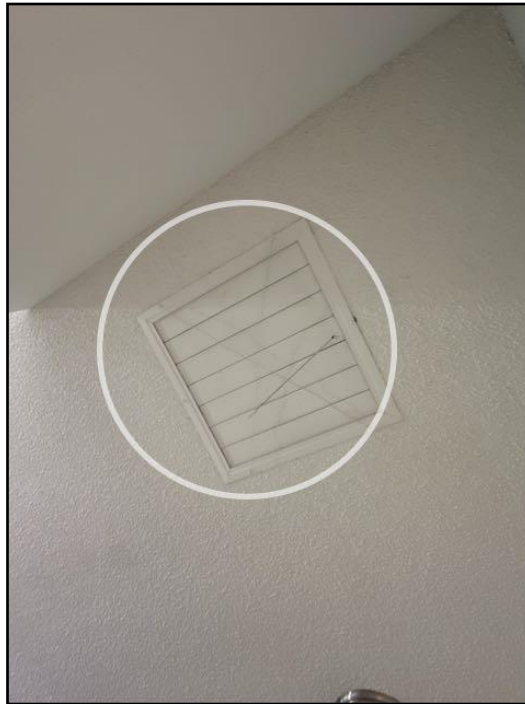
129.

Condition: • The whole house fan doesn't have any insulation or foam insulation attached. This can increase energy costs if not done. The fan also is extremely loud and sounds like something is loose or it's banging on the roof structure

Task: Further evaluation by qualified professional recommended to repair or replace and correct issue as needed.

Add insulation or replace part of the ceiling vinyl slats for a different type.

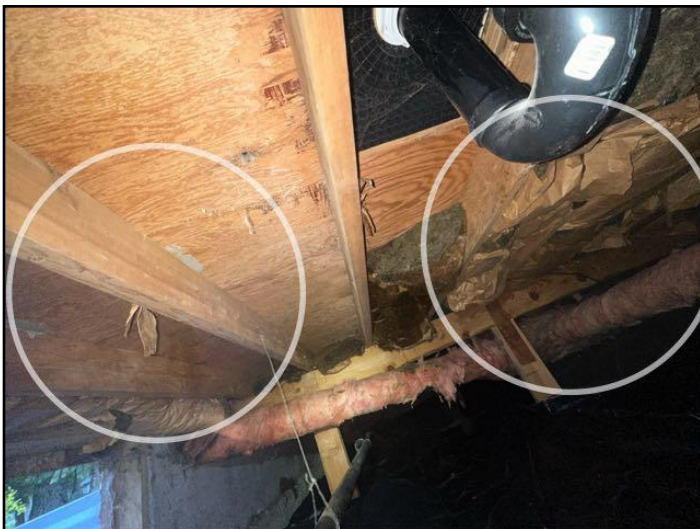
Condition: • [Loose, sagging or voids](#)

Location: Various spots throughout

131. Loose, sagging or voids

Task: Repair or replace insulation

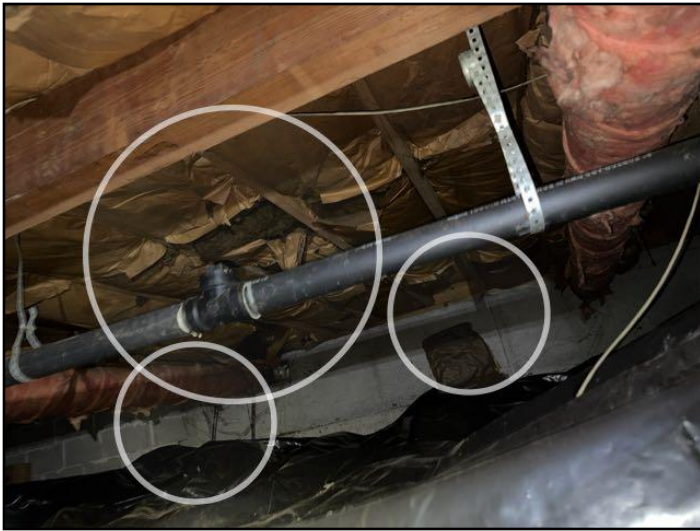
133. Loose, sagging or voids

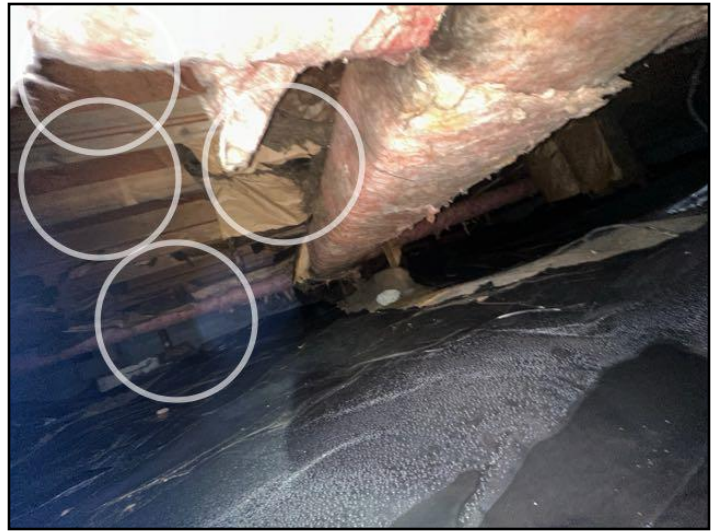
134. Loose, sagging or voids

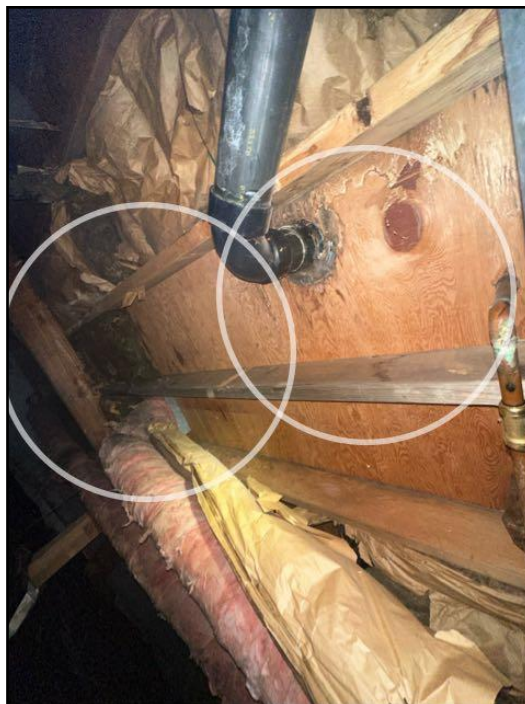
135. Loose, sagging or voids

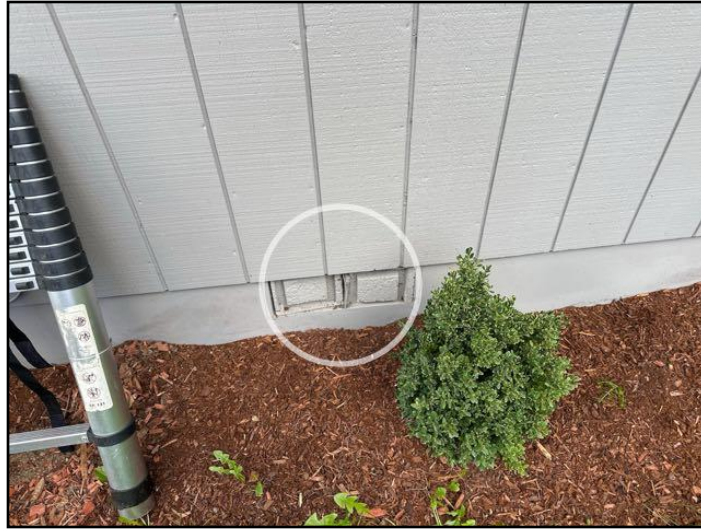
Condition: • Obstructed

136. *Obstructed*

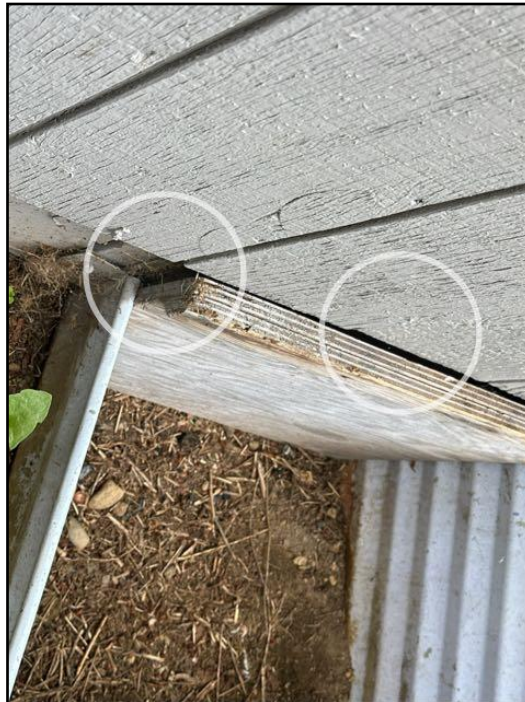
Condition: • Does not fit tightly

137. *Does not fit tightly*

Task: Provide tightly sealed door

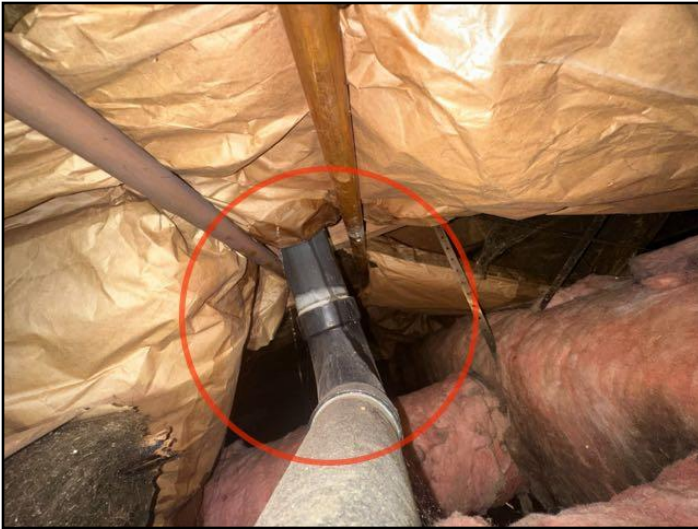
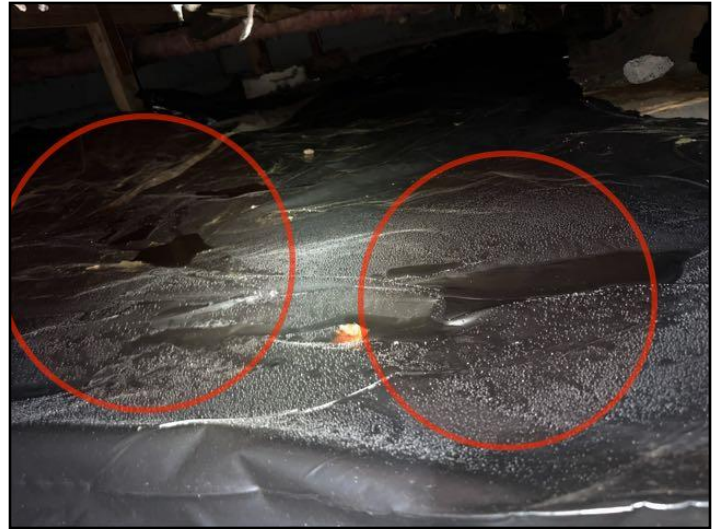
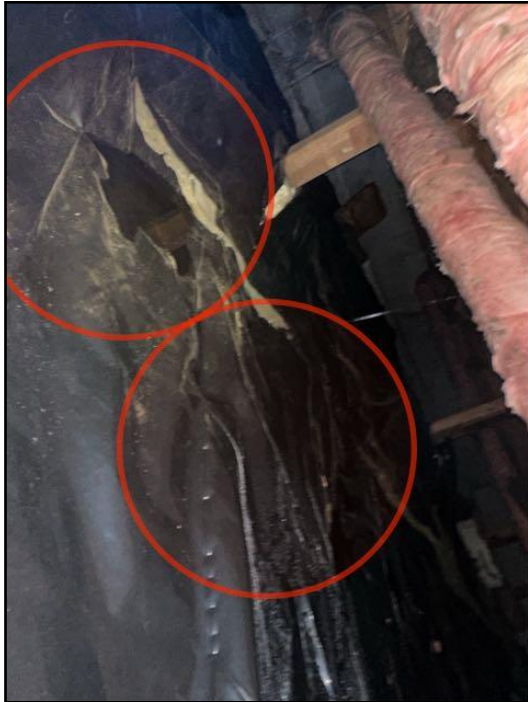
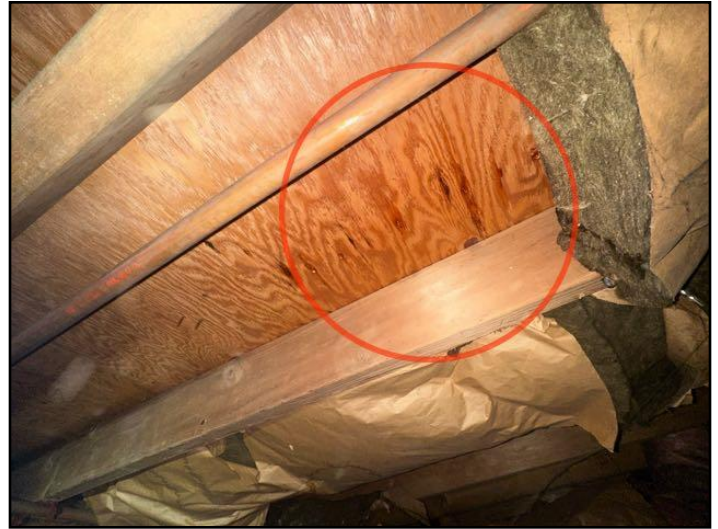
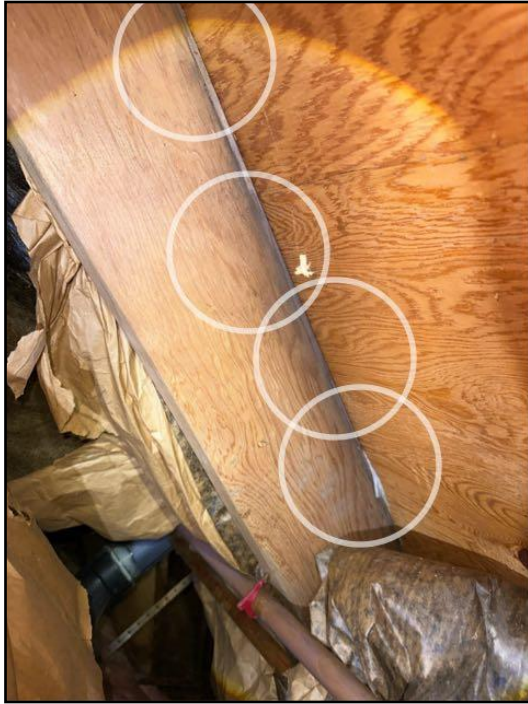
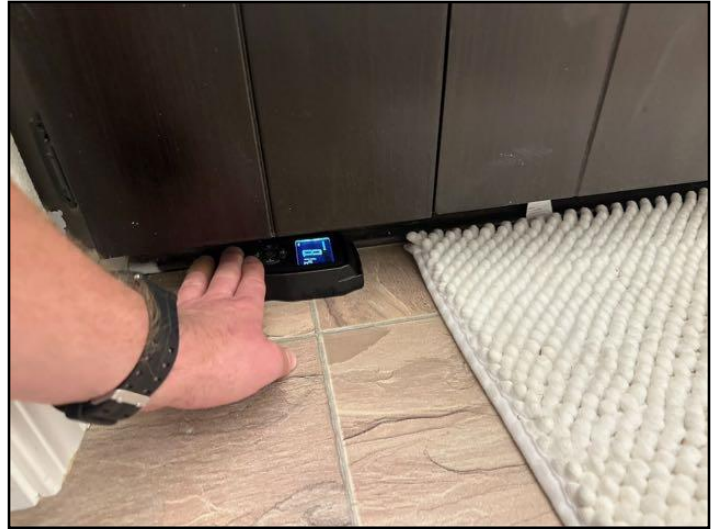
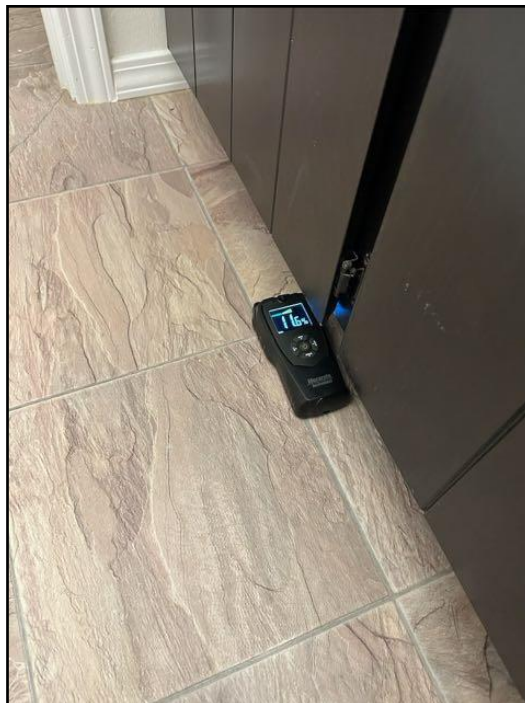
Condition: • There are several leaks in the crawlspace, some near the bathrooms, some under, and some closer to the hall. There is signs of water staining on the floor joists which may indicate this has been going on a while. The sub flooring is saturated with moisture and is shown on the laminate flooring in the bathroom. Most of the moisture appears to be under the sink cabinet.

Task: Further evaluation by qualified professional recommended to repair or replace and correct issue as needed.

Time: As soon as possible

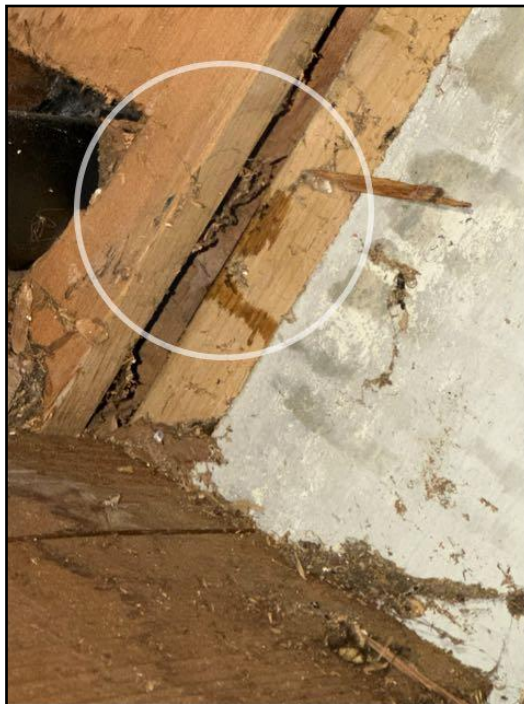
150.

Condition: • Leak u see kitchen sink cabinet with water staining

Task: Further evaluation by qualified professional recommended to repair or replace and correct issue as needed.

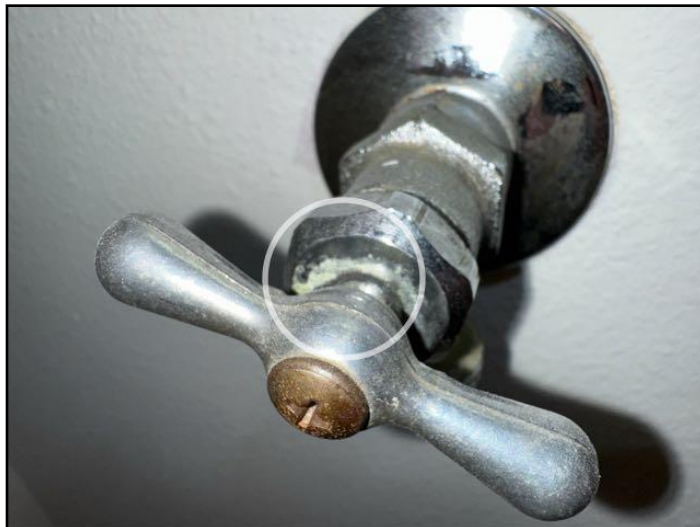
151. Corrosion

Condition: • Corrosion

Signs of corrosion. Plumbing valves and connections at fixtures including but not limited to sinks and toilets will typically corrode quicker than the main homes supply plumbing. When corrosion or rust gets significant enough or rubber gaskets in the valves start to crack leaks can occur. If leaking or heavy corrosion has started and all of the fixtures valves were bought around the same time, the others may start leaking in the near future. This is similar to a lot of things in the home including light bulbs.

Location: Laundry room valves, hall bathroom valves,

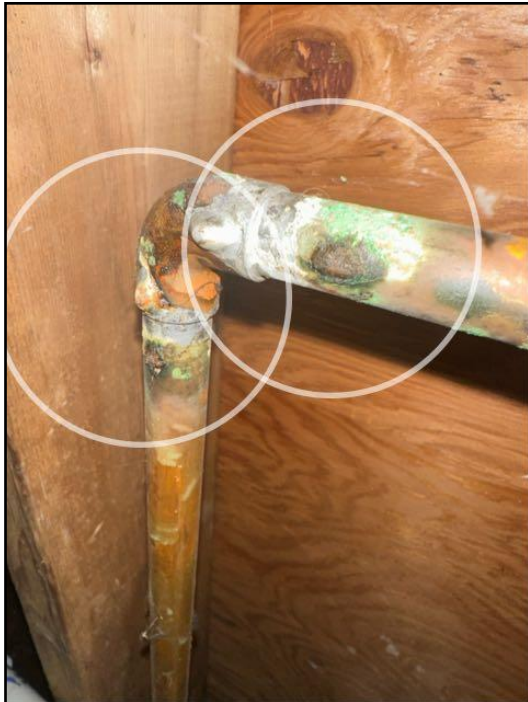
152. Corrosion

Condition: • Corrosion

Copper pipes, along with most pipes have a life expectancy which may be around 50 years depending on quality of product and installation methods. There are some signs that help gauge the condition. Discoloration would be greenish or bluish stains on the pipes, which can indicate corrosion. Visible leaks or wet spots around the pipes. Low water pressure could be due to mineral buildup or corrosion inside the pipes. If the water tastes or smells metallic, it could be a sign of corrosion in the pipes. Dents bulges or other physical damage to the pipes, which could indicate issues. A licensed professional should further evaluate if any of these conditions arise. Solder flux will cause copper pipes to turn green if not wiped off. The discoloration is limited to areas bordering soldered joints, so it is likely caused by the flux not being wiped off back when the connections were originally soldered. It should be limited to surface discoloration, so I'd use something abrasive like emery cloth or steel wool to remove it. See link below for education on copper pipes life expectancy. <https://todayshomeowner.com/plumbing/guides/how-long-does-copper-pipe-last/>

Location: Various spots throughout

Task: Have plumber evaluate and replace if needed

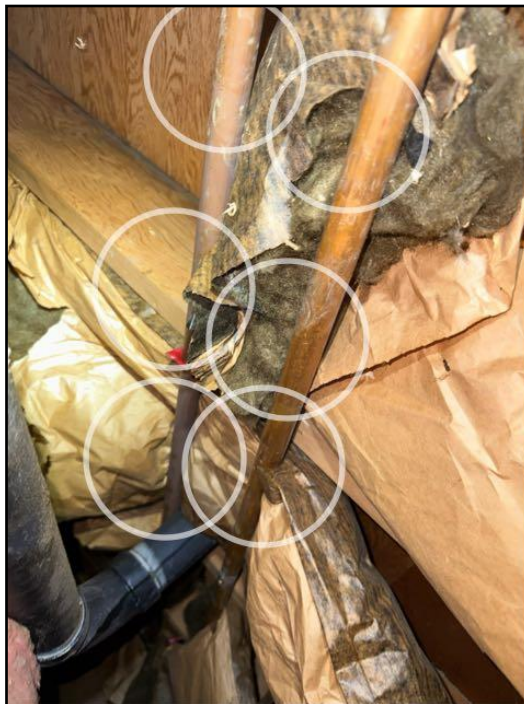
154.

Condition: • Piping in the crawlspace isn't insulated

Task: Insulate

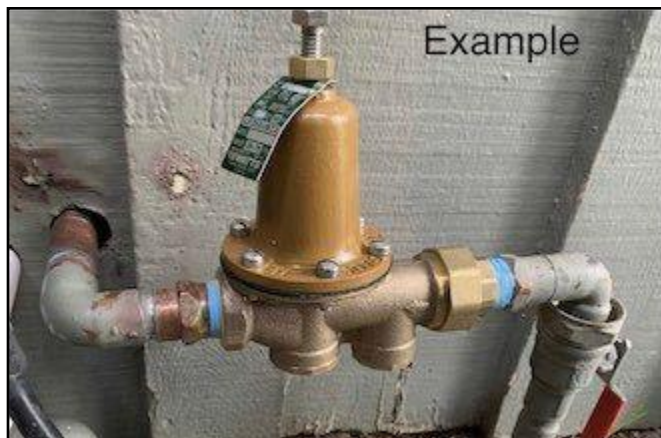
156. Recommended due to high supply water...

Condition: • Recommended due to high supply water pressure
Residential plumbing should be between 40-80PSI.

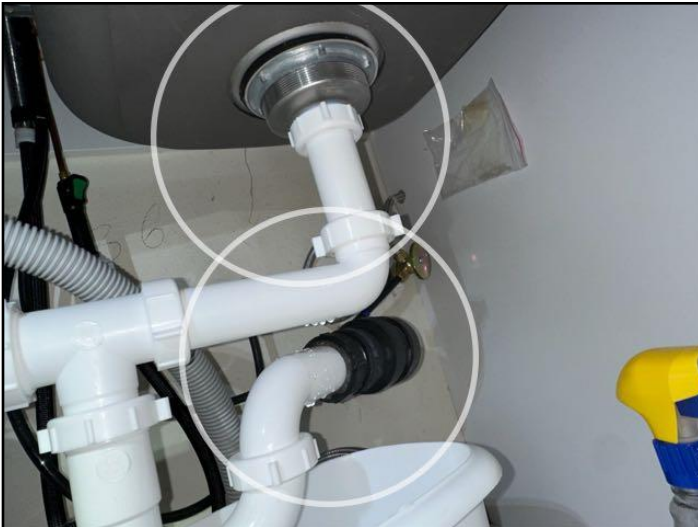
158. Leak

Condition: • [Leak](#)

Task: Further evaluation by qualified professional recommended to repair or replace and correct issue as needed.

Time: As soon as possible

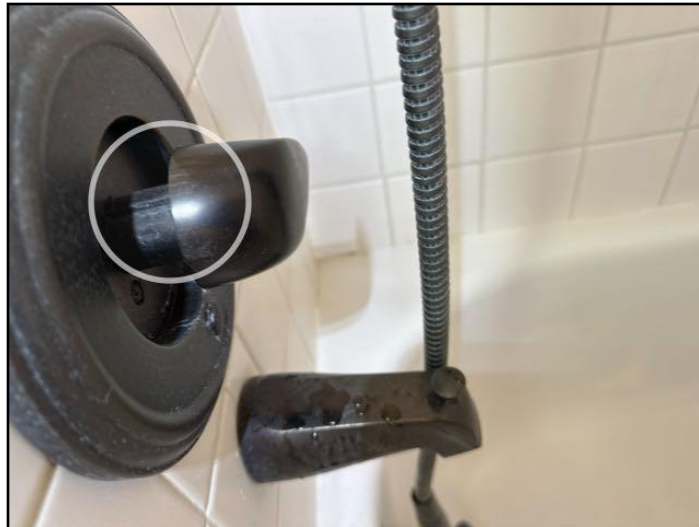
161.

Condition: • The hall shower would not work during inspection. I was unable to inspect the plumbing for leaks

Task: Further evaluation by qualified professional recommended to repair or replace and correct issue as needed.

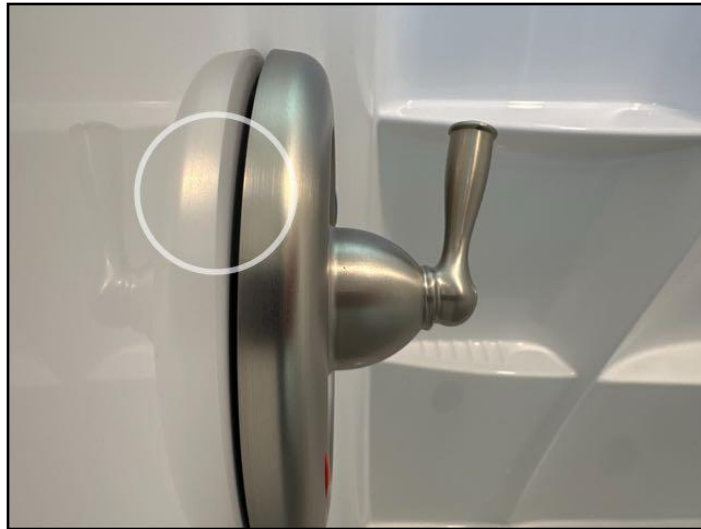
162.

Condition: • Gaps around the shower handle

Time: Seal gaps

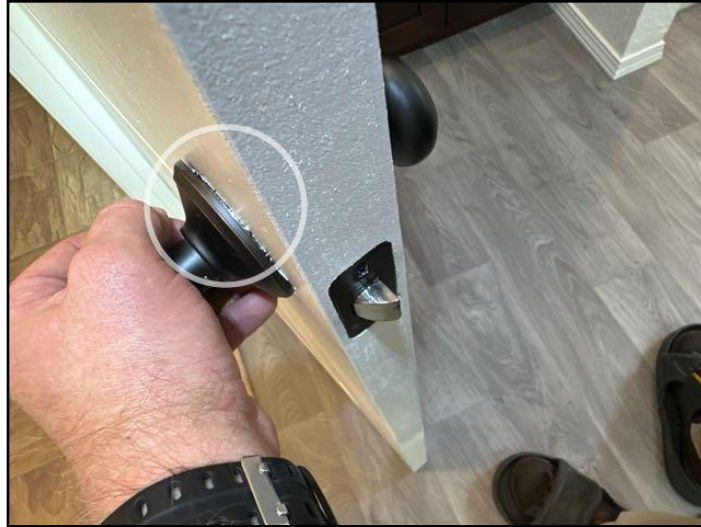
166. Loose

Condition: • [Loose](#)

Location: Primary bedrooms bathroom door

Task: Adjust/correct

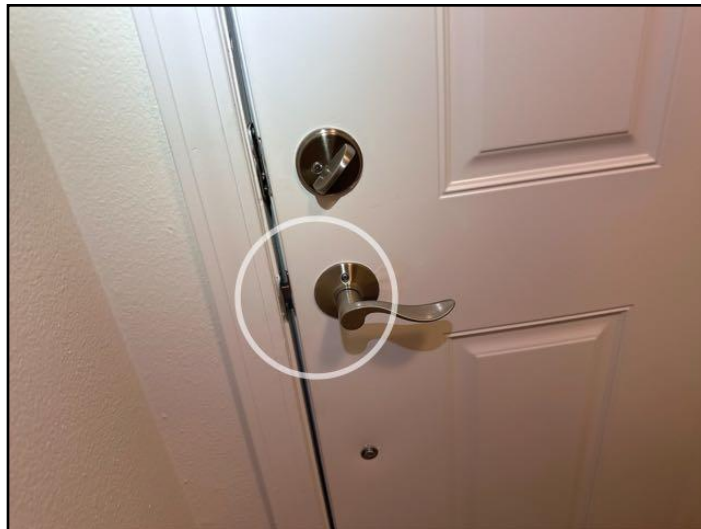
167. Latch not effective on exterior door

Condition: • Latch not effective on exterior door

Location: Front door

Task: Adjust/correct

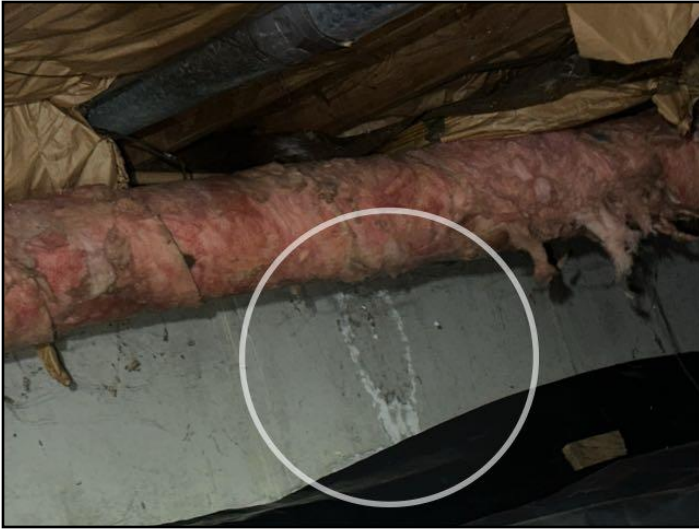
169. Efflorescence

Condition: • [Efflorescence](#)

Moisture problems are frequently found in the basement of a home or building especially older homes in the PNW. Crawlspaces may be less common but are not exempt from these issues. Even in some of the driest of site conditions, foundations are continually exposed to moisture vapor from the ground. When basements are used inappropriately...

riately on sites with high groundwater, or in areas with intermittent periods of higher ground moisture levels due to rainfall and water table fluctuations, they are frequently exposed to bulk water. Therefore, foundations must be detailed to deal with the potential for water leakage through cracks and joints, capillary movement of water through foundation materials, vapor transmission of moisture through foundation materials, and condensation of moist air on cool foundation surfaces. A qualified professional should evaluate as there are several different reasons why water may be an issue. Some may include but not limited to, poor backfill, compacted backfill, no vapor barrier on the exterior wall, no swale, poor lot grading, poor downspout extensions, and high water table or springs. Much older homes are more likely to show signs of previous or current issues. It is difficult to know what attempts for proper drainage were used over the years but it was more common to not have gutters or downspout extensions back in the day. Depending on the severity and if it is an active issue, a qualified professional should evaluate and make a correction or corrections. Some corrections may include but not limited to, extending downspouts, correcting the grading or providing a swale, sealing gaps or water proofing the concrete wall from the exterior, creating a drainage system IE French drain system, or creating a sump pump drainage system.

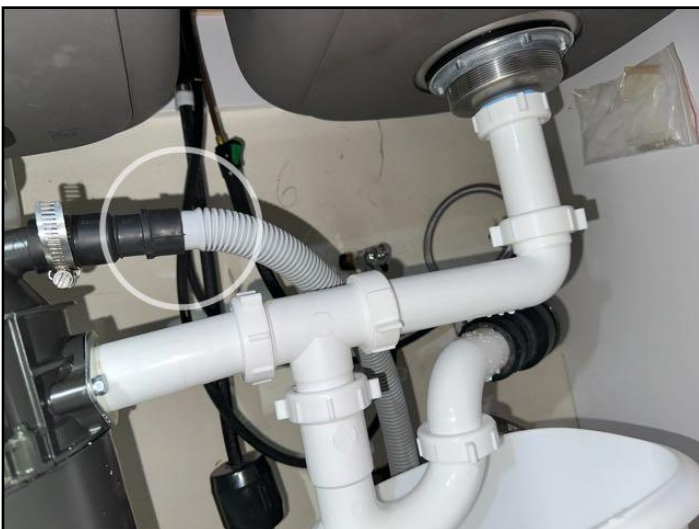
171. Backflow prevention high loop missing

Condition: • Backflow prevention high loop missing

A high loop is a raised waste line between the dishwasher and the kitchen sink waste line. Attaching the dishwasher drain to the upper portion inside the kitchen sink cabinet can help prevent waste water back-flow in low flow or clogging conditions. Essentially without the high loop there is a possibility that waste water will enter into the dishwasher. Some dishwashers have a high loop in the machine but is still recommended under the sink. Some back-flow prevention devices are installed into the actual sink as an air gap, but most older sinks and older homes typically didn't/don't have that type of installment. If the dishwasher hose is long enough then this would be a relatively simple and cheap task to accomplish.

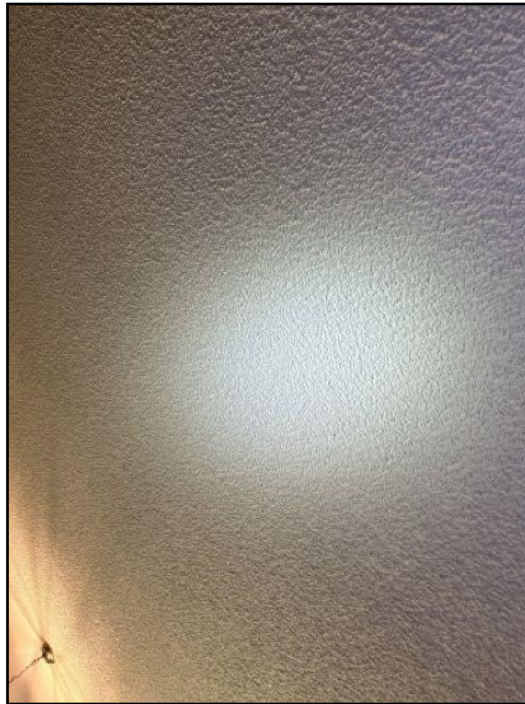
174. Possible asbestos containing materials

Condition: • Possible asbestos containing materials

Asbestos was manufactured and used in various homes up until 1978 and some shortly after. Asbestos in homes should not be disturbed. Asbestos in a home isn't inherently bad except when damaged, small particles of dust can be harmful. If planning on removing any asbestos I recommend getting it tested and having a properly licensed company do so with the proper safety equipment and procedures to do so. Some items that may contain asbestos include but are not limited to floor tiles, ceiling tiles, siding, roofing a specific type of insulation, white ducting tape, popcorn ceilings, electrical wiring, and lap & plaster walls. Here's some useful links. <https://www.asbestos.com/asbestos/information/>
