INSPECTION REPORT

For the Property at:
1234 INSPECTION STREET
PUYALLUP, WA 98374

Prepared for: BUYER .
Inspection Date: Wednesday, October 9, 2024
Prepared by: Chad Fletcher

RE: Report No. 1616, v.0
1234 inspection street
Puyallup, WA
98374

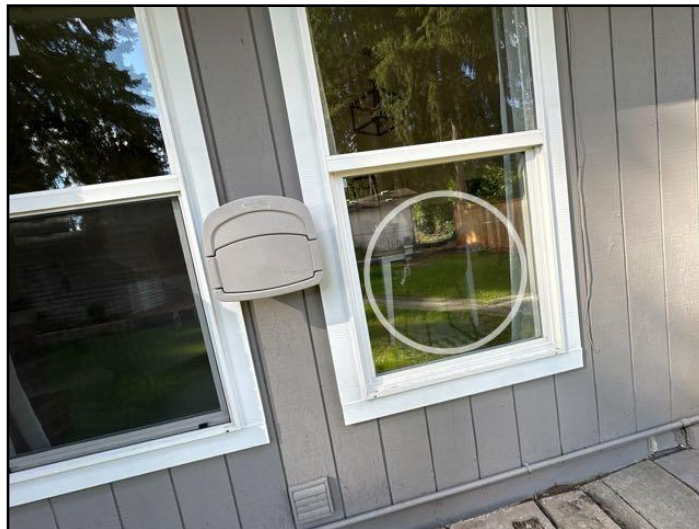
175.

Condition: • Missing window screen

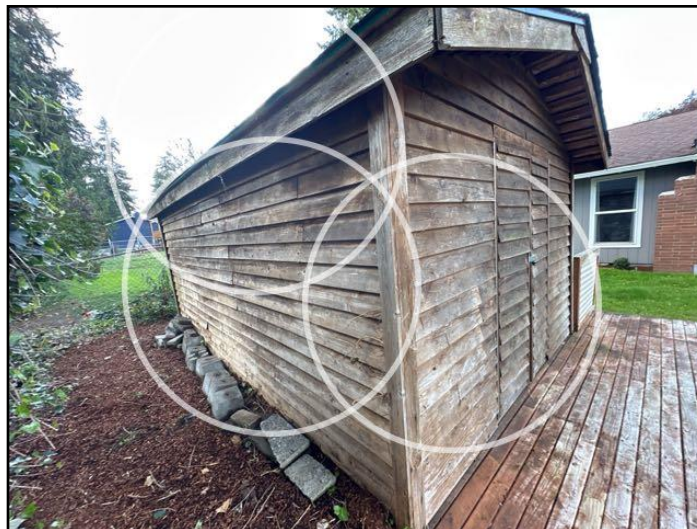
177.

General: • Old stain and missing gutters/downspouts at shed

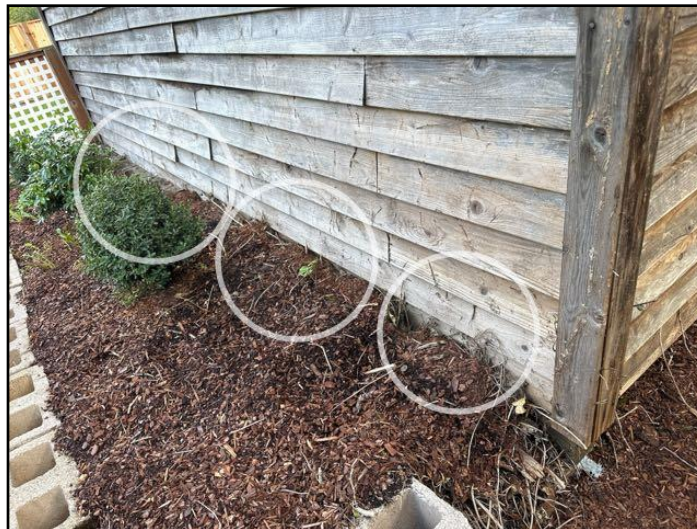
178.

General: • Wood soil contact can damage wood

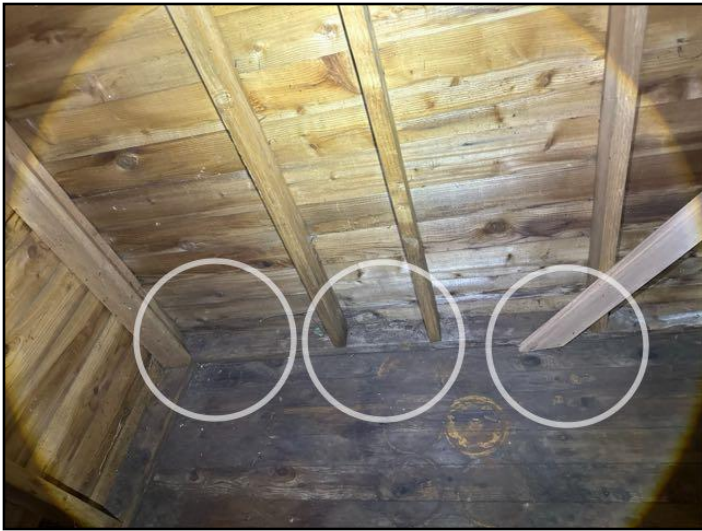
179.

General: • Small amounts of mildew growth and water stains. The siding has gaps around it
